HERITAGE IMPACT ASSESSMENT: PROPOSED HOOGLAND SOUTHERN GRID CONNECTION, BEAUFORT WEST MAGISTERIAL DISTRICT, WESTERN CAPE

Required under Section 38(8) of the National Heritage Resources Act (No. 25 of 1999)
as part of a Heritage Impact Assessment.

Hoogland Southern Grid Connection

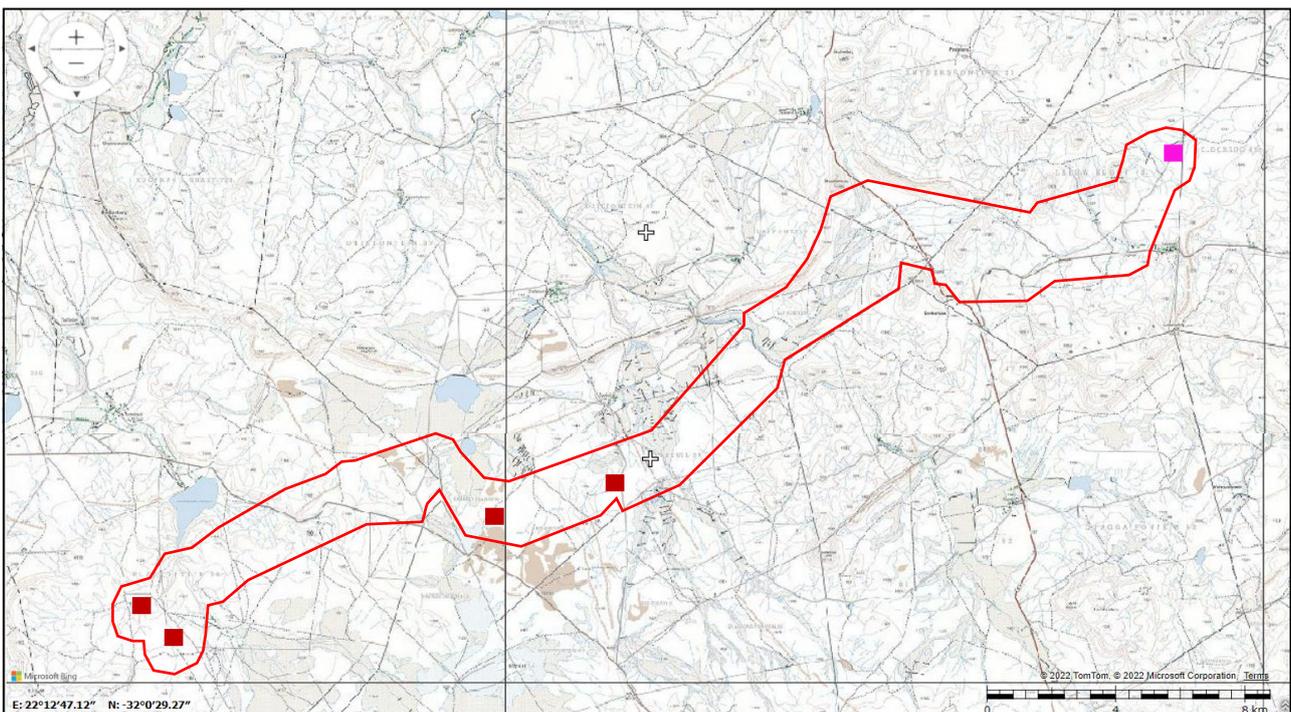
Figure 1-2: Extract from 1:50 000 mapsheets 3122cc &cd showing the location of the Hoogland Southern Grid Connection corridor (red polygon). The red squares show the switching station locations, while the pink square is the Nuweveld Collector Substation which does not form part of this application. Source of basemap: Chief Directorate: National Geo-Spatial Information. Website: <http://www.cdngiportal.co.za/cdngiportal/>.

The scope of this report is the Hoogland Southern Grid Connection. Approximate end points for the corridor under consideration (Figure 1-2) are as follows:

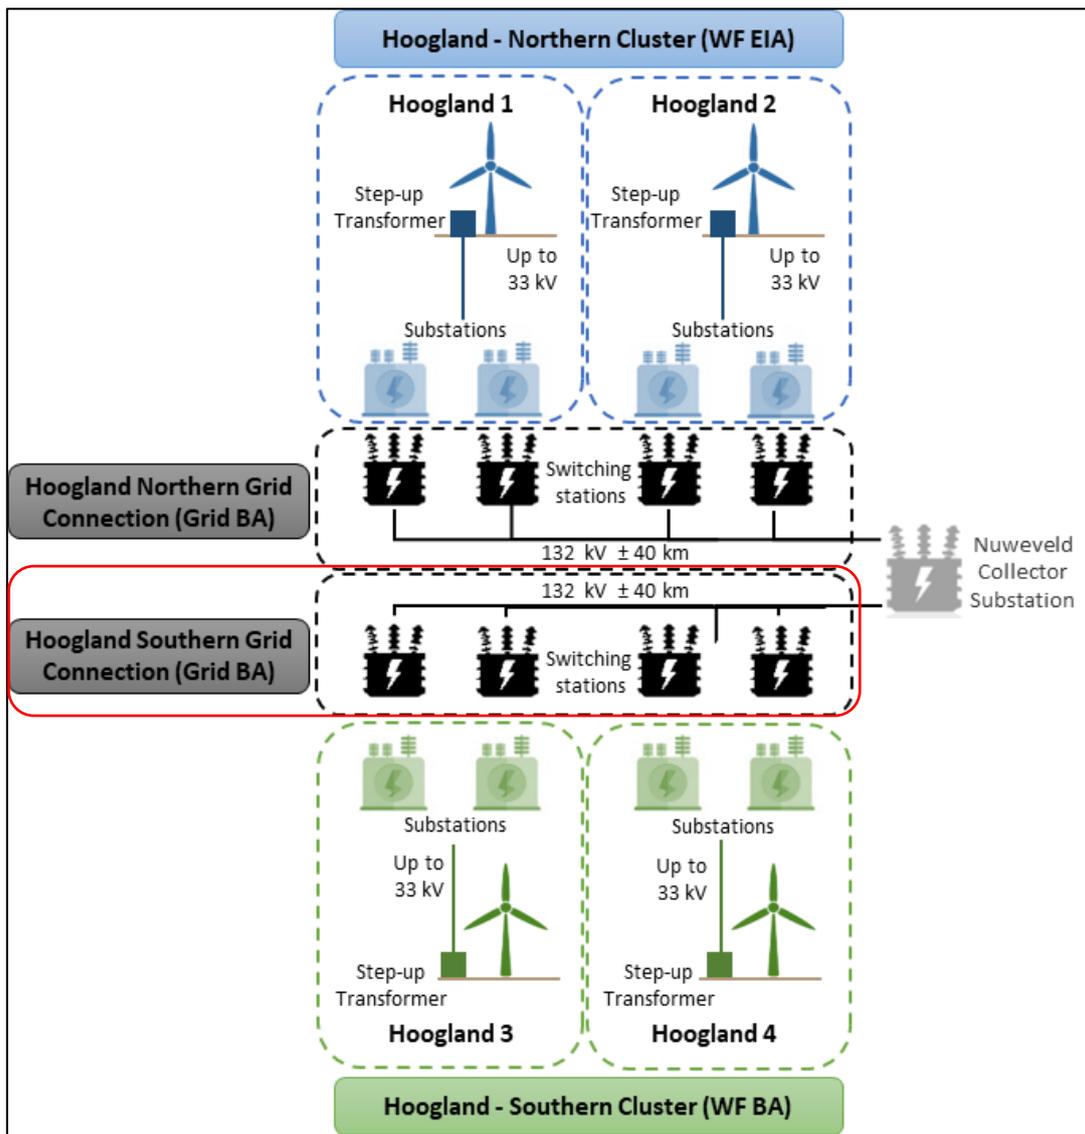
Figure 1-3: Power transmission - Wind farm and grid connection interface (Hoogland Southern Grid Connections shown in red block).

The power is then transferred through a switching station (next to each of the Wind Farm substations) along a 132 kV line to the proposed Nuweveld Collector Substation and there it will be stepped up to 400 kV for evacuation to the national grid. The Nuweveld Collector Substation is not part of this project and has already been granted Environmental Authorisation.

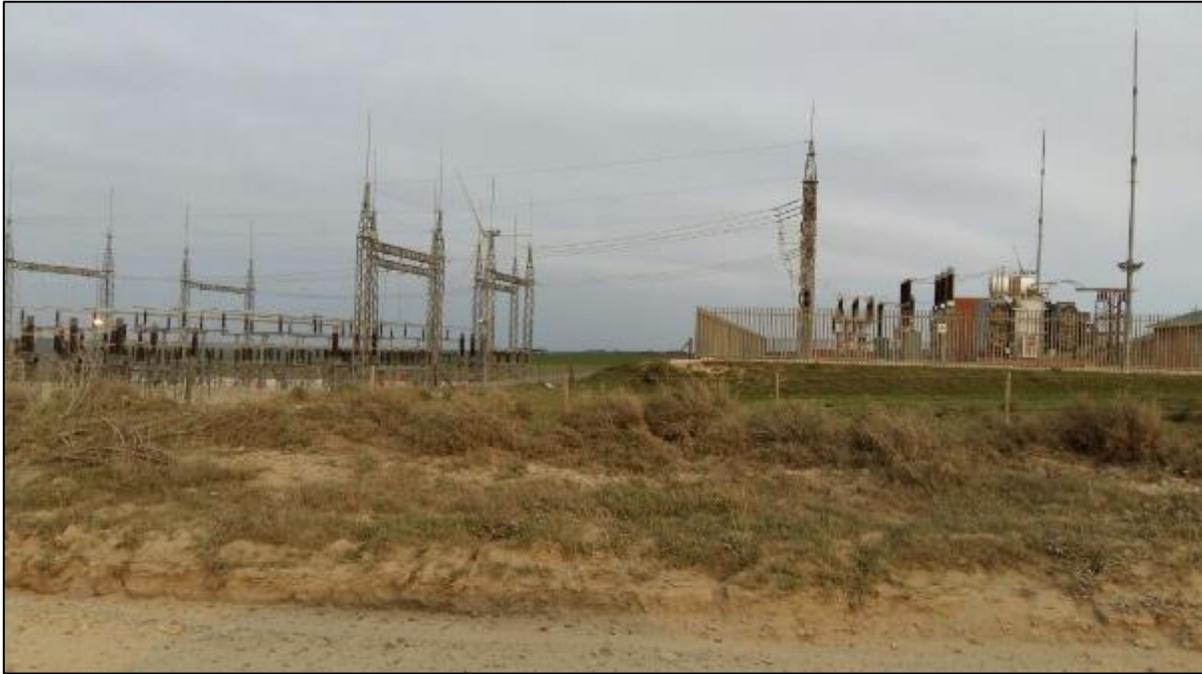
Figure 1-4: Example of an Eskom switching station (left) and adjoining Wind Farm substation (right) on the Kouga Wind Farm.

Each switching station will be located alongside the respective Wind Farm substation. There will be a physical barrier between the two in the form of a ± 2.4 m high perimeter fence (Figure 1-4 shows an example). The Eskom switching stations on each Hoogland Wind Farm will each have a total footprint of approximately 150 x 75 m (11 250 m²). The switching station area will include all the standard switching station electrical equipment/components, such as bus bars, metering equipment, switchgear, and will also house control, operational, workshop and storage buildings/areas.

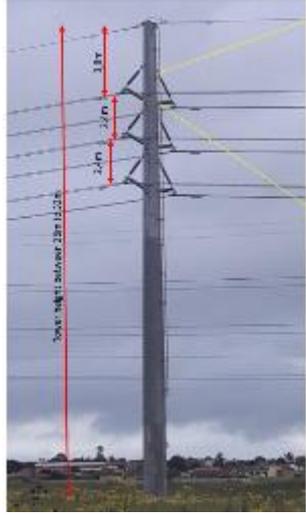
Tower Type	Description and purpose	Illustration
1.	132kV Intermediate Self-Supporting Single Circuit Monopole	<p>Self-supporting galvanised steel monopole intermediate or suspension structure with no stays/anchors. The monopole is designed to support a double electrical circuit with a twin conductor arrangement.</p> <p>This structure will be used as intermediate structures between inline strain or angle strain points. This structure will also be the most common structure used for a double circuit line at an estimated 60% to 80% of the total number of structures.</p> <p>Monopole Height: Between 26 m and 32 m. Pole top diameter: 380 mm to 450 mm Pole Base diameter: 1.2 m to 1.5 m</p>

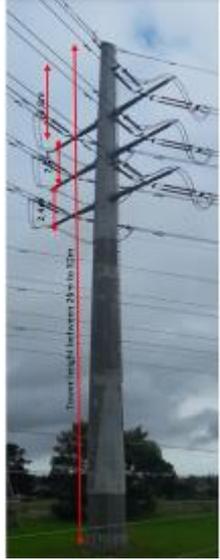
2.	132kV Inline or Angle Strain Self-Supporting Double Circuit Monopole	<p>Self-supporting galvanised steel monopole inline or angle strain structure with no stays/anchors. the monopole is designed to support a double electrical circuit with a twin conductor arrangement.</p> <p>The number of inline or angle strain points estimated in the order of 20% to 40% of the total number of structures.</p> <p>Monopole Height: Between 26m and 32m. Pole top diameter: 380mm to 450mm Pole Base diameter: 1.8m to 2.5m</p>

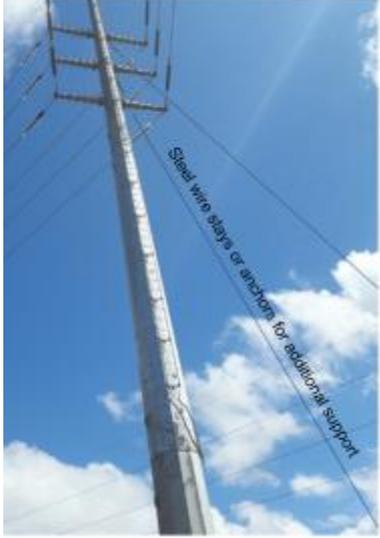
3.	132kV Inline or Angle Strain Guyed Double Circuit Monopole	<p>Galvanised steel monopole inline or angle strain structure with anchors/stays for additional structure support. This monopole is similar to the self-supporting monopole but with additional anchor support for conditions where longer span lengths is required with higher conductor tensions.</p> <p>The monopole with anchors is design to support the conductor tensions associated with the conductor weight and longer span lengths.</p> <p>Monopole Height: Between 26 m and 32 m. Pole top diameter: 380 mm to 450 mm Pole Base diameter: 1.8 m to 2.5 m</p> <p>Anchors/Stays: Depending on the angle strain point up to 4 x anchors.</p>

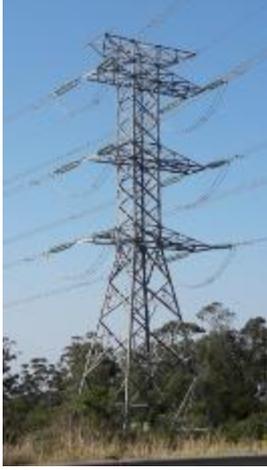
Tower Type	Description and purpose	Illustration
4.	132kV Inline or Angle Strain Lattice Steel Tower for double circuit line	<p>Galvanised steel inline or angle strain lattice tower for conditions where longer span lengths across valley in exceptional cases is required with higher conductor tensions. (500 m to 800 m spans)</p> <p>Tower Height: Between 31 m and 38 m.</p> <p>Foundations: 4 x concrete foundations for 4 x legs of the tower. Base of the tower with 4 legs in general 15 m x 15 m area.</p>

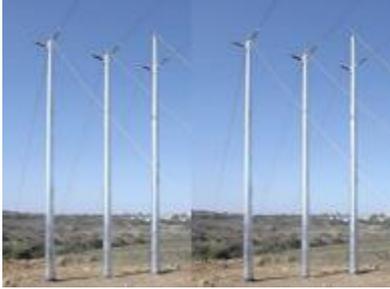
5.	Triple pole structure 2 x Single circuit with up to Twin Tern Conductor	<p>For long spans (>350 m to 500 m) across valleys and rivers.</p> <p>Strain structure with three single monopoles per circuit. 5-9 stays per triple pole structure depending on angle configuration.</p> <p>Height: Typically 18 to 16 m.</p> <p>In a double circuit configuration, it will be a triple pole structure per circuit placed at 10 m-15 m apart (see figure).</p>

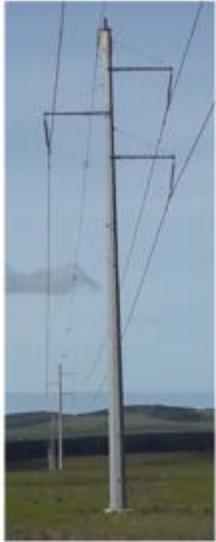
6.	132kV Suspension Self-Supporting Single Circuit Monopole with single conductor	<p>Self-supporting galvanised steel monopole suspension structure with no stays/anchors. The monopole is designed to support a single electrical circuit with a single conductor arrangement.</p> <p>This structure will be used as an intermediate structure between inline strain or angle strain points. This structure will also be the most common structure used for a single circuit line, at an estimated 50% to 70% of the total number of structures.</p> <p>The structure is designed to support the conductor weight as well as the wind loading specifications.</p> <p>Monopole Height: Between 22 m and 26 m. Pole top diameter: 230 mm Pole Base diameter: 650 mm</p>

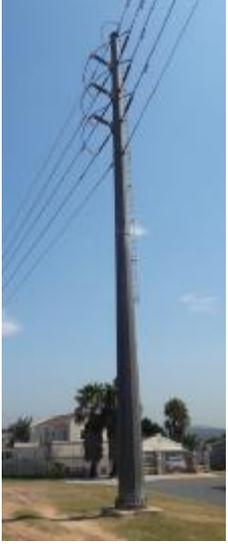
Tower Type	Description and purpose	Illustration
7.	132kV Inline or Angle Strain Self-Supporting Single Circuit Monopole with single conductor	<p>Self-supporting galvanised steel monopole inline or angle strain structure with no stays/anchors. The monopole is designed to support a single electrical circuit with a single conductor arrangement,</p> <p>This structure will be used as a strain structure and will be positioned at the angle points along the line or as an inline position where a strain point is required due to the ground elevation. The number of inline or angle strain points estimated in the order of 30% to 40% of the total number of structures.</p> <p>Monopole Height: Between 24 m and 30 m. Pole top diameter: 380 mm Pole Base diameter: 1 m to 1.2 m</p>

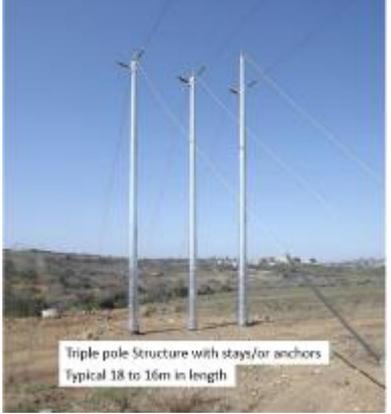
8.	Triple pole structure 1 x Single circuit with up to Twin Tern Conductor	<p>For long spans (>350 m to 500 m) across valleys and rivers.</p> <p>Strain structure with three single monopoles. 5-9 stays per triple pole structure depending on angle configuration.</p> <p>Height: Typically 18 to 16 m.</p>

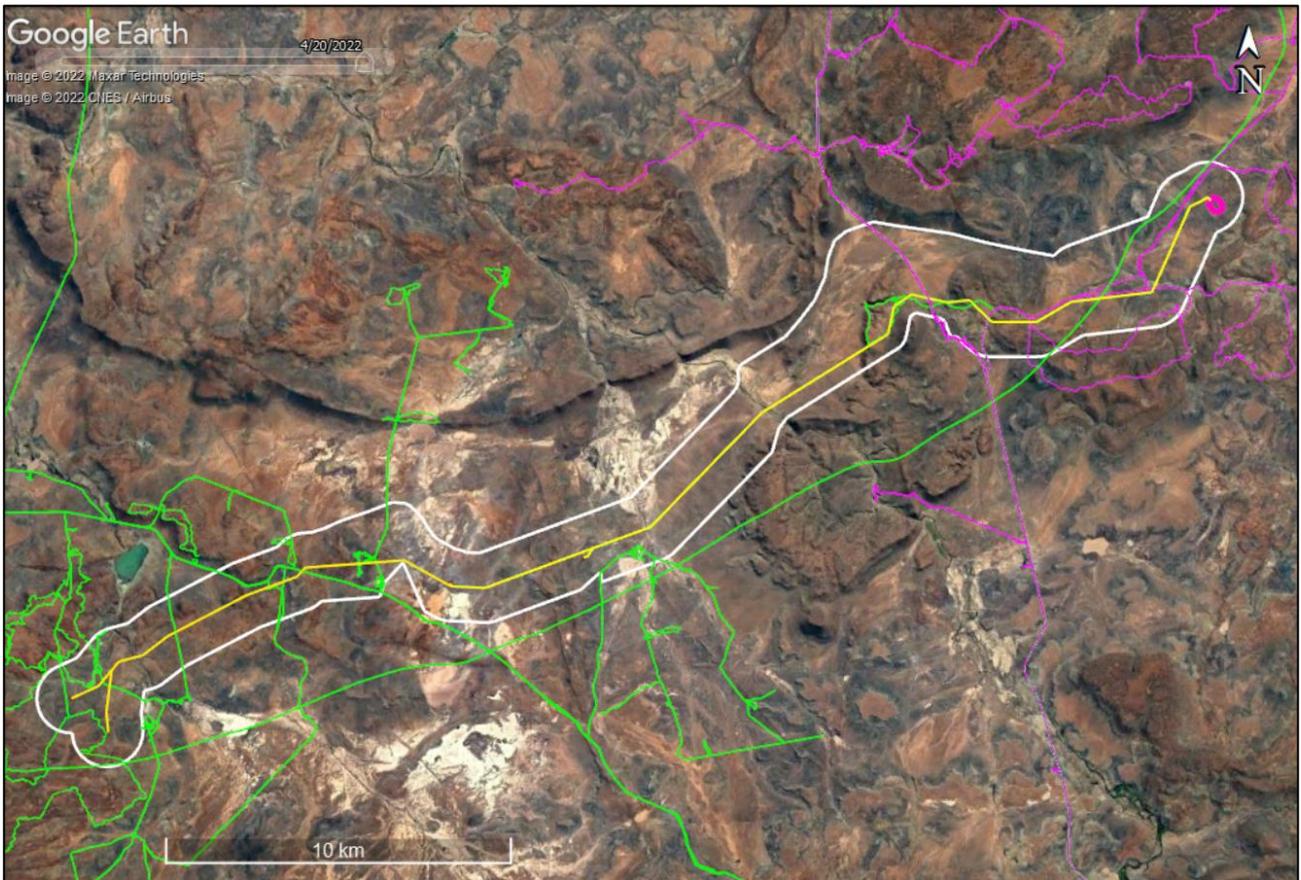
Figure 3-1: Aerial view of the study area (white polygon with indicative provisional alignment in yellow) showing the survey tracks (green [2021] and purple [2019] lines).

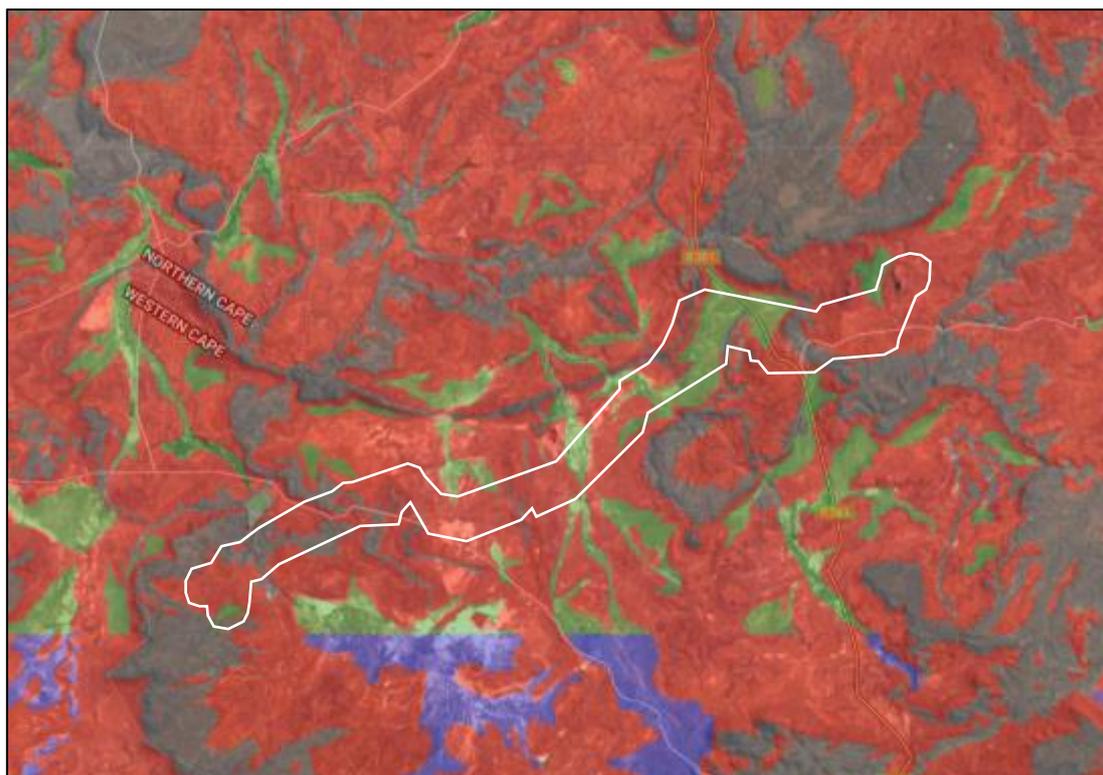
Figure 5-1: Extract from the SAHRIS Palaeosensitivity map showing the study area to be of very high, moderate and zero palaeontological sensitivity (red, green and grey shading respectively).

The SAHRIS Palaeosensitivity map shows the study area to be of largely very high sensitivity but with patches of moderate and zero sensitivity (Figure 5-1).

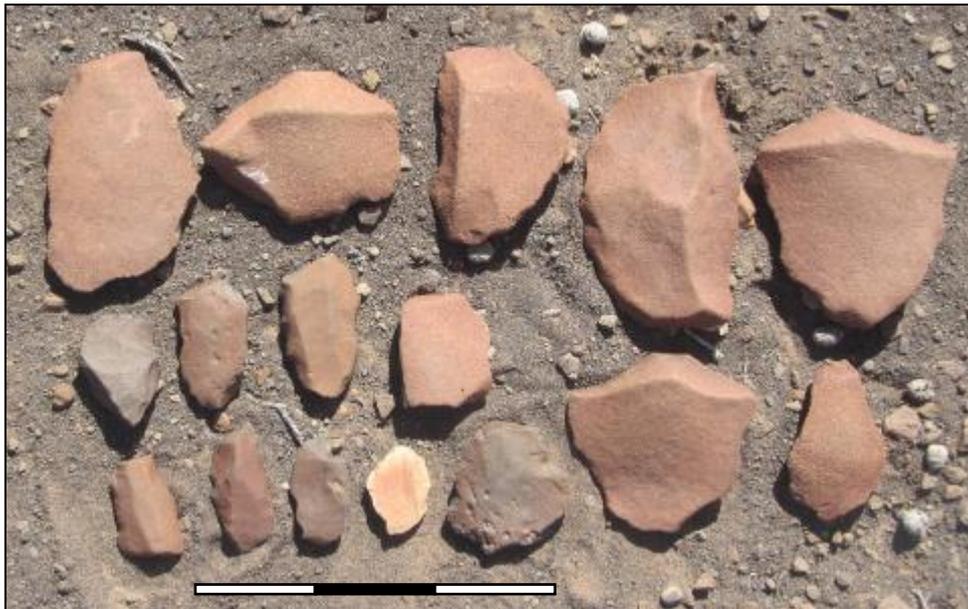
Figure 5-7: Collection of very well-patinated sandstone flaked stone artefacts dating to the MSA and possibly ESA (waypoint HL1550). Scale = 5 cm.

ESA and MSA materials were very rarely seen, but some isolated artefacts occur as very low density background scatter on the silty plains. One area of denser scatter was seen, however, at waypoint 1550 which is just outside the current corridor (Figure 5-7).

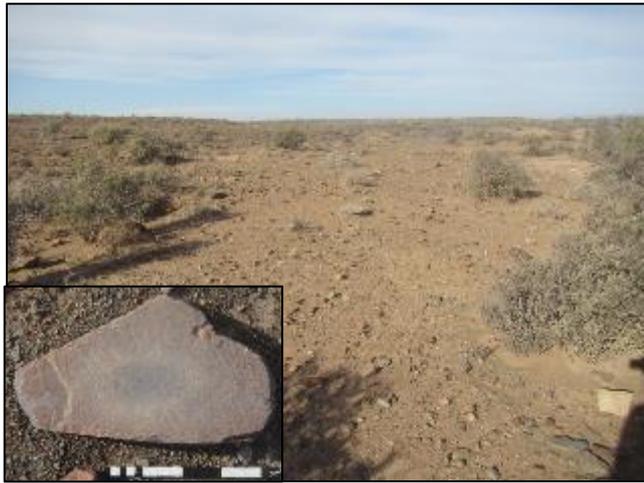
Figure 5-8: The location of the dense LSA artefact scatter at waypoint HL211.

A few proper LSA occupation sites were found, but all were surface scatters. One was an extensive artefact scatter on the northern side of a river (waypoint HL211; Figure 5-8 & Figure 5-9). Most artefacts are in hornfels but a few are in quartz. There are also many ostrich eggshell fragments and one piece of *Unio caffer* (freshwater mussel) was seen. The site lies outside of the current corridor. Many other LSA sites occurred but most were ephemeral to light scatters of stone artefacts, sometimes including ostrich eggshell fragments. They tend to focus on river terraces and on or alongside dolerite ridges (e.g. Figure 5-11 located outside the current corridor) but most were fairly low density.

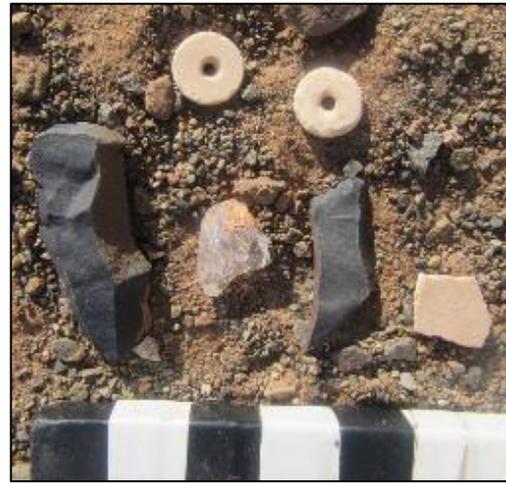
Figure 5-9: Stone artefacts and ostrich eggshell at waypoint HL211. Scale in cm.

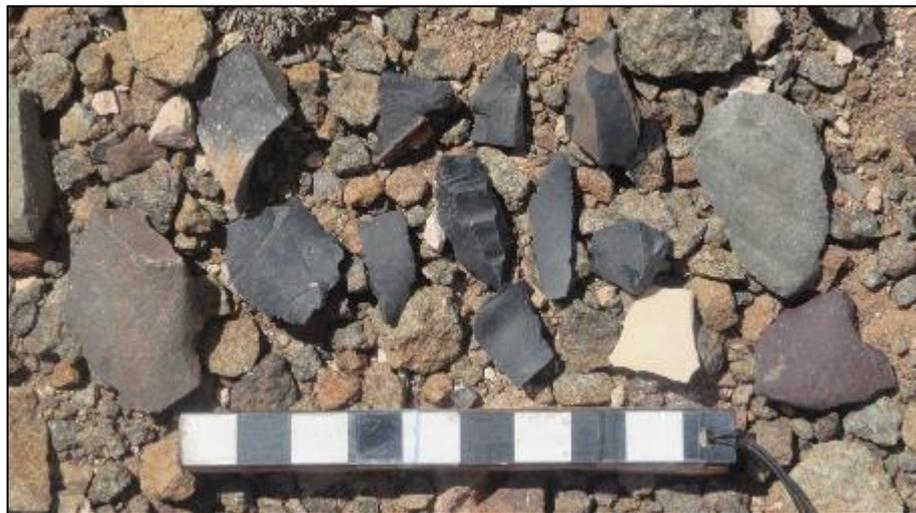
Figure 5-10: Stone artefacts and ostrich eggshell at waypoint HL1613. Scale in cm.

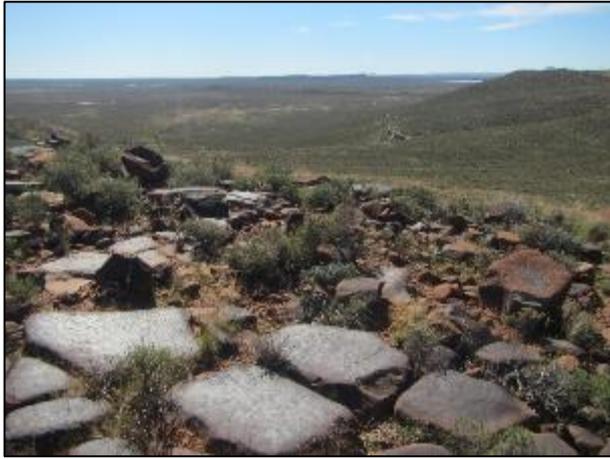
Figure 5-11: The location of the eland engraving at waypoint HL1581.

Quite a few LSA engraved sites have been found, with most being towards the western end of the corridor, and outside of the corridor. Many are poorly preserved and difficult to photograph adequately. An eland engraving was found at waypoint HL1581 on the edge of a ridge (Figure 5-11 outside the current corridor). This is a typical location for LSA engravings. It was scraped, but some incisions have been made over the image – these may be related to ritual activity (Figure 5-12). Figure 5-13 shows a dolerite slab at waypoint 1574 (outside the corridor) with many engravings on it. The majority are historical but a very clear scraped eland engraving dating to the LSA is clearly visible. It is overprinted by the later historical scratched images. Figure 5-14 to Figure 5-16 show three further LSA engravings, again all from outside the corridor.

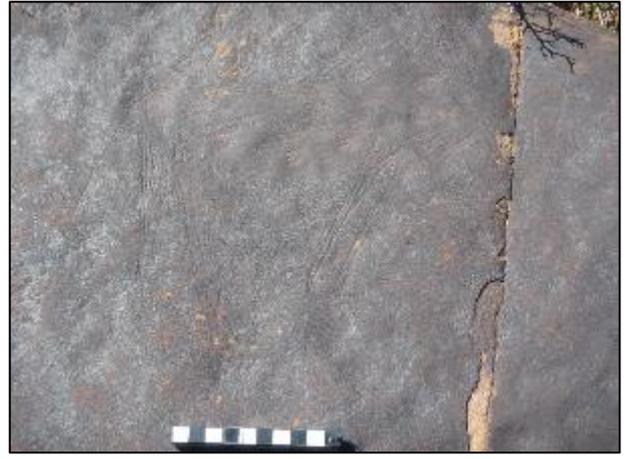
Figure 5-12: The eland engraving at waypoint HL1581. Scale in cm.

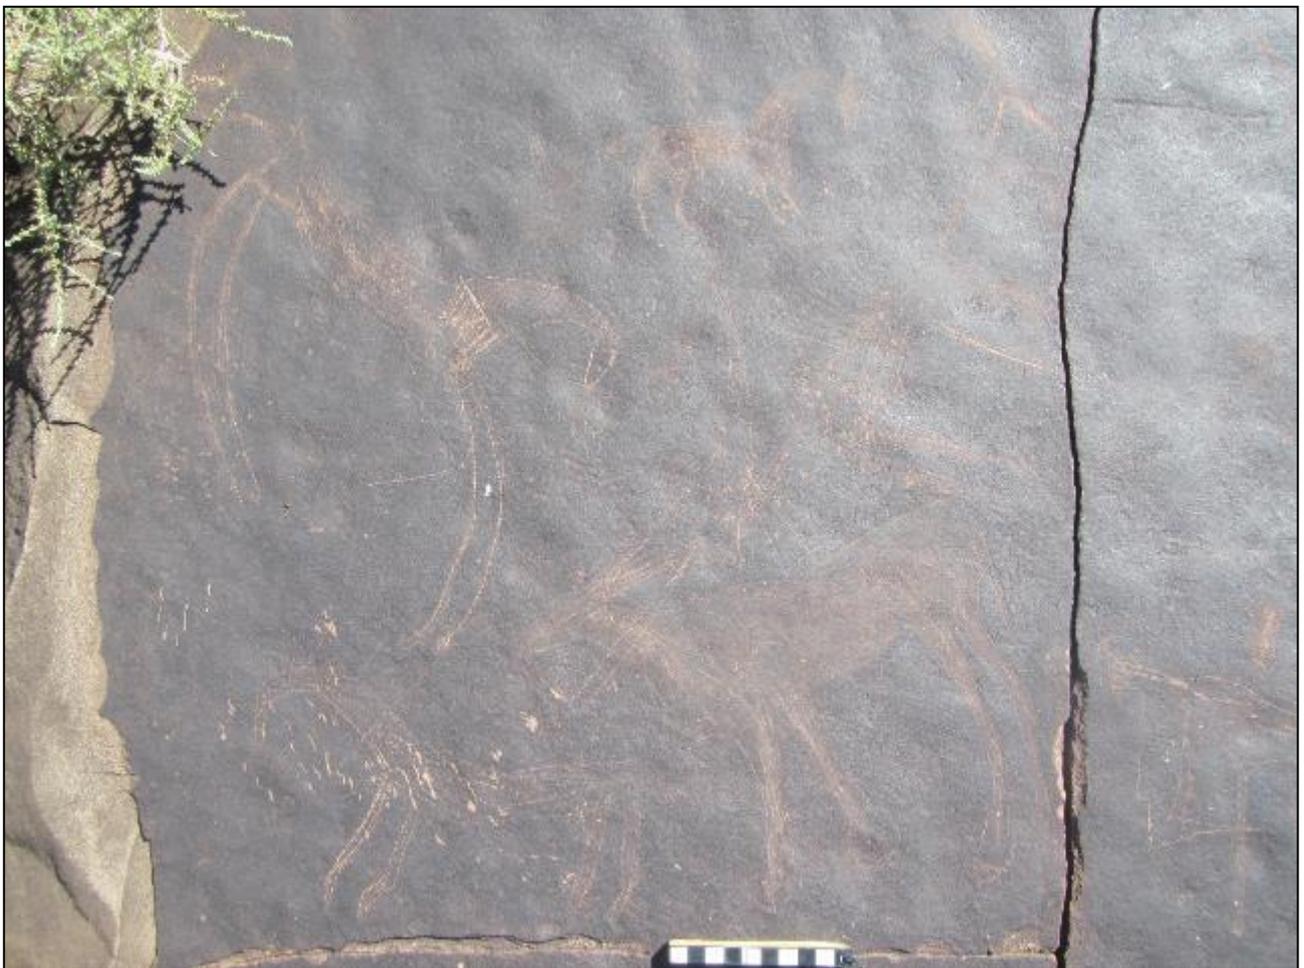
Figure 5-13: Dolerite boulder with many engraved animals on it at waypoint HL1574. The majority are historical scratchings and depict horses, but a scraped eland occurs in the centre. Scale in cm.

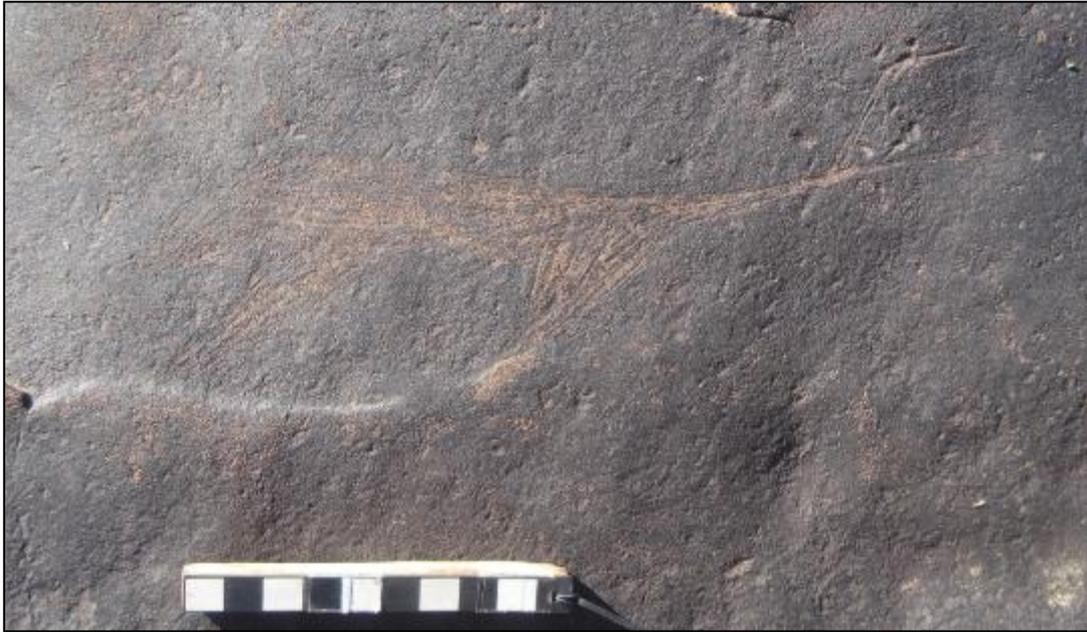
Figure 5-14: An enigmatic scraped animal engraving with head to the left and a bifurcated tail from waypoint HL1859. Scale in cm.

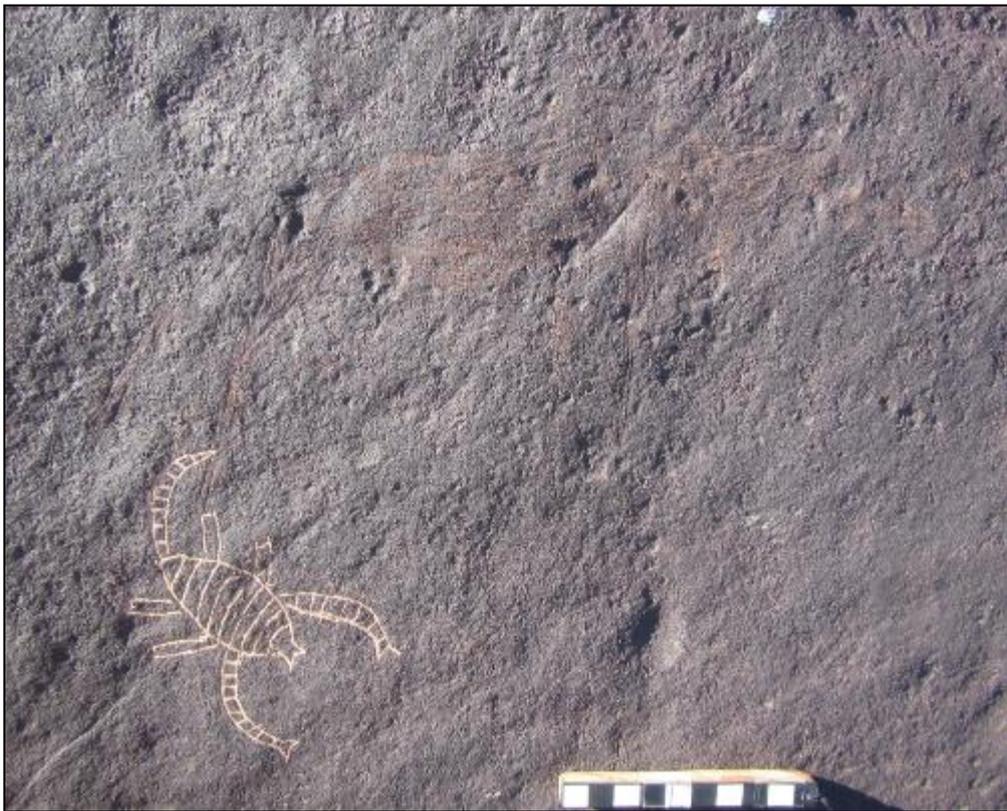
Figure 5-15: A scraped eland engraving with a very recently scratched scorpion overprinted from waypoint HL1860. Scale in cm.

As noted above, the historical engravings of the area demonstrate continuity in the tradition of engraving. This signature is very strongly present in the area to the northwest of the western end of the corridor but poorly represented elsewhere. What is perhaps of greatest interest is that the engraving tradition appears to have continued even longer than expected as evidenced by the clearly very recent scorpion engraving shown above (Figure 5-15) and an engraving dated 1934 from elsewhere in the wider study area.

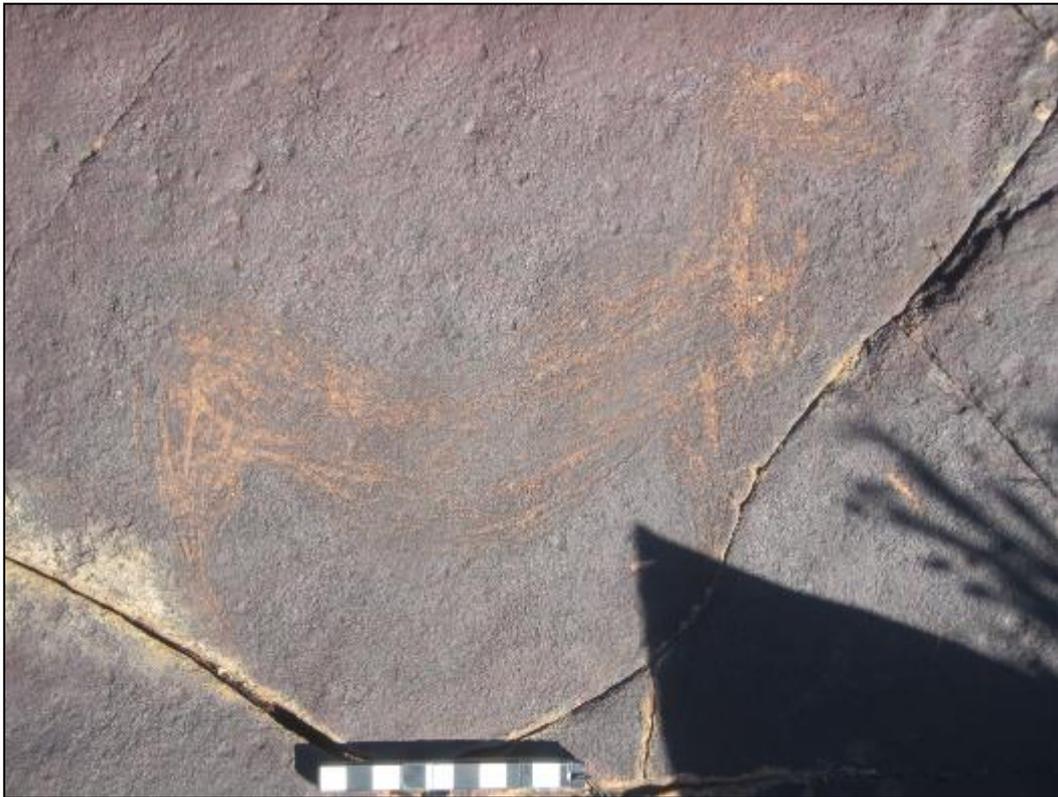
Figure 5-16: A scraped eland engraving with its back arched downwards from waypoint HL1862. Scale in cm.

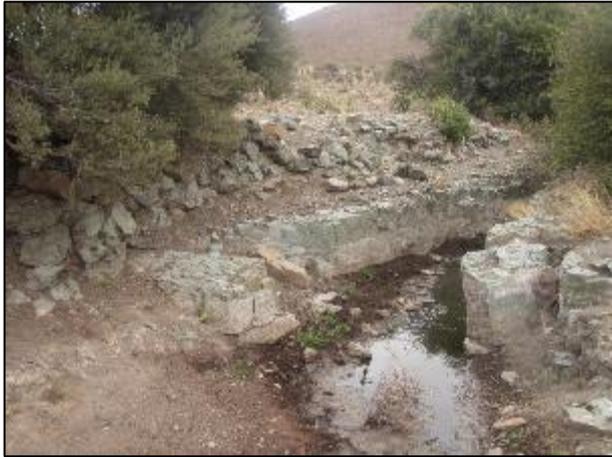
Figure 5-17: Water reservoir at waypoint HL1810.

One such complex is located just west of the R381 on Lapfontein 40 and located within the grid corridor. The 1:50 000 topographic map does not name or even mark the site. The complex lies along a stream bed and comprises of several features. Within a tributary of the main stream some excavation of bedrock has taken place at waypoint HL1810 with walling added to create a small reservoir (Figure 5-17). Another small wall has dammed the same stream further down but it has long since been breached (waypoint HL1818). Figure 5-18 shows a small stone-walled structure that is likely to have had a residential function at waypoint HL1811, while Figure 5-19 shows a large kraal whose walls are badly tumbled (waypoint HL1812). Stones may well have been removed from the site for reuse elsewhere. Although not very well visible at ground level, it is very clear when viewed from above (Figure 5-20).

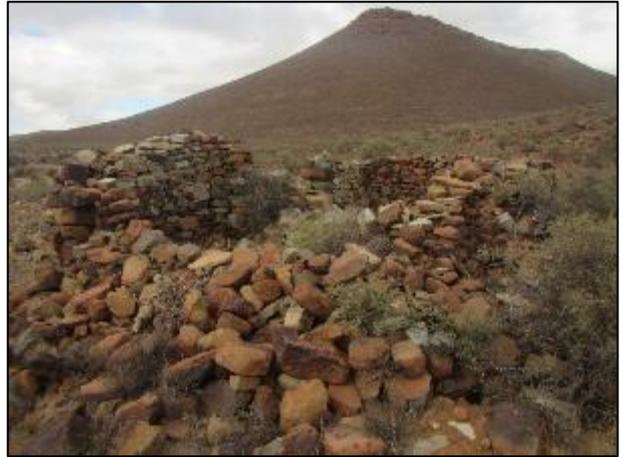
Figure 5-18: Stone-walled ruin at waypoint HL1811.

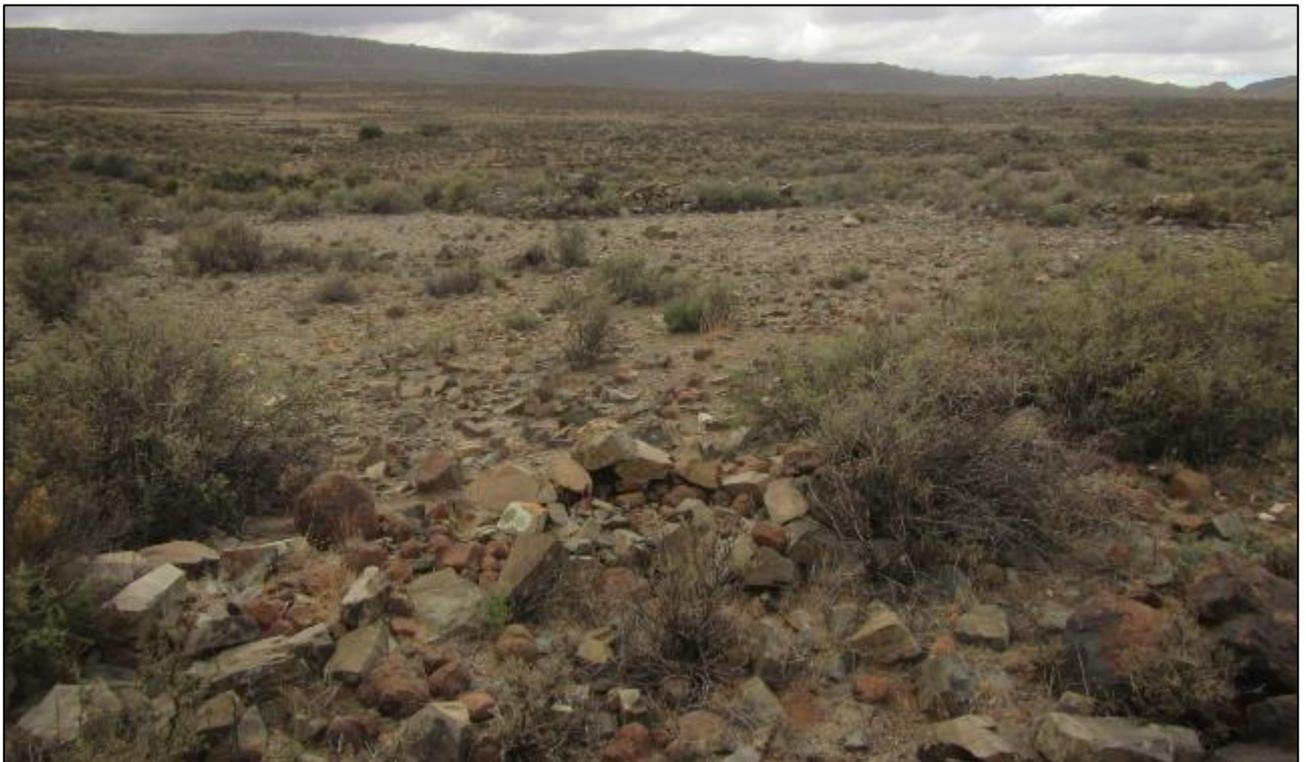
Figure 5-19: A badly tumbled stone-walled kraal at waypoint HL1812. The semi-cleared area is inside the kraal.

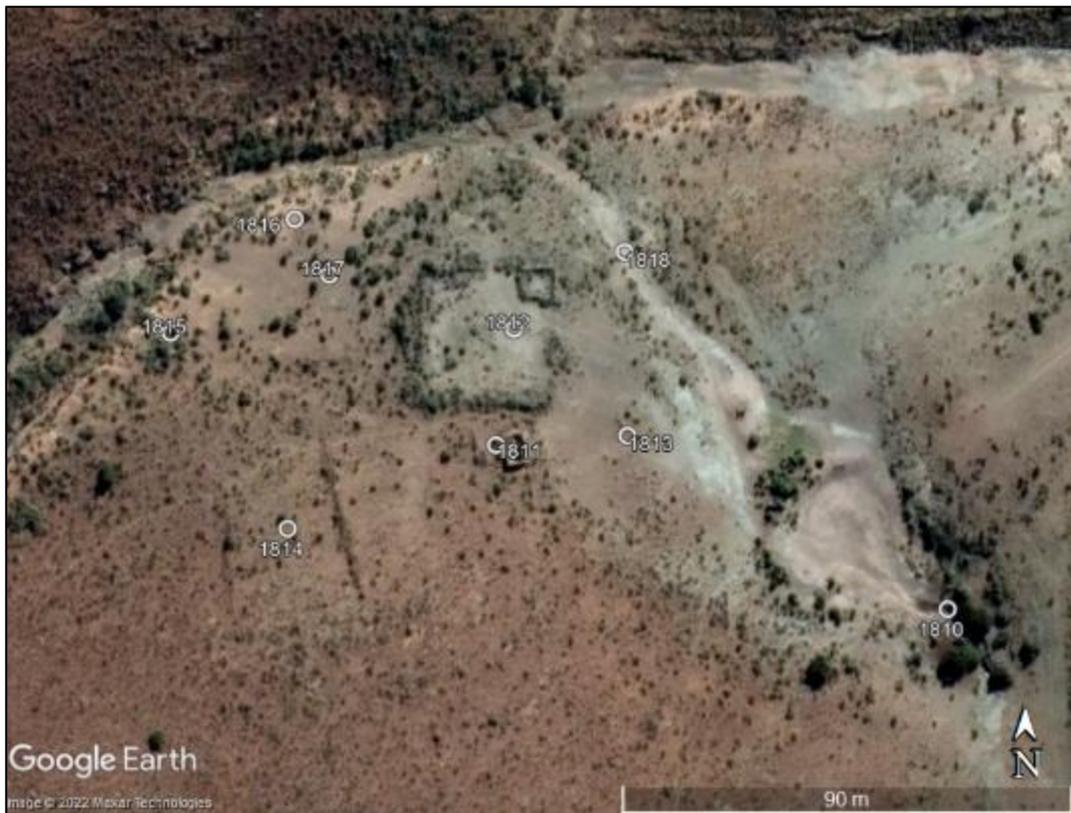
Figure 5-20: Aerial view of the complex described above (waypoints HL1810-1818).

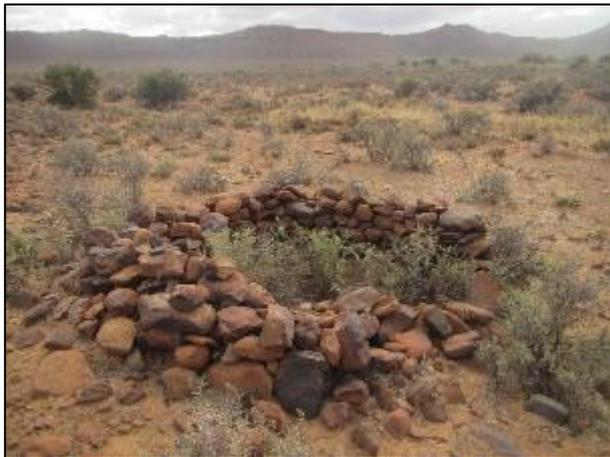
Figure 5-21: Stone-walled enclosure at waypoint 1819.

Not far away, at the base of the hill on which this complex lies and also within the corridor, were two small stone-walled enclosures, each only about 2 m across (waypoints HL1819 & HL1820; Figure 5-21 & Figure 5-22)

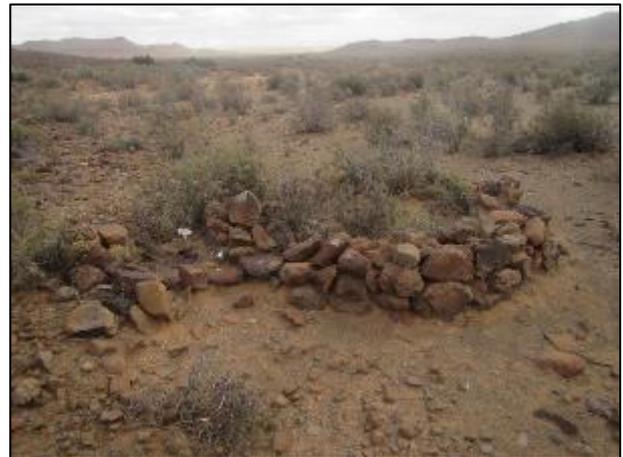
Figure 5-22: Stone-walled enclosure at waypoint 1820.

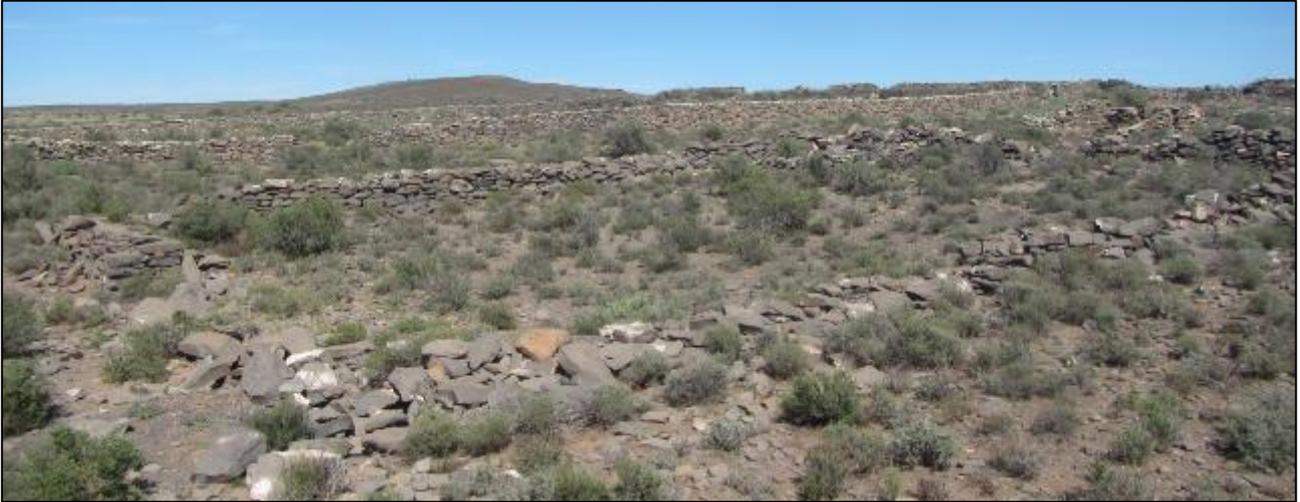
Figure 5-23: The stone-walled kraal at waypoint 1588.

Elsewhere in the corridor, a very large stone-walled kraal (waypoint HL1588; Figure 5-23) was built close to a dam which, interestingly, had a stone building erected on the northern end of its wall (Figure 5-24). A light scattering of artefacts occurred outside the ruin (Figure 5-25). Proper ash and

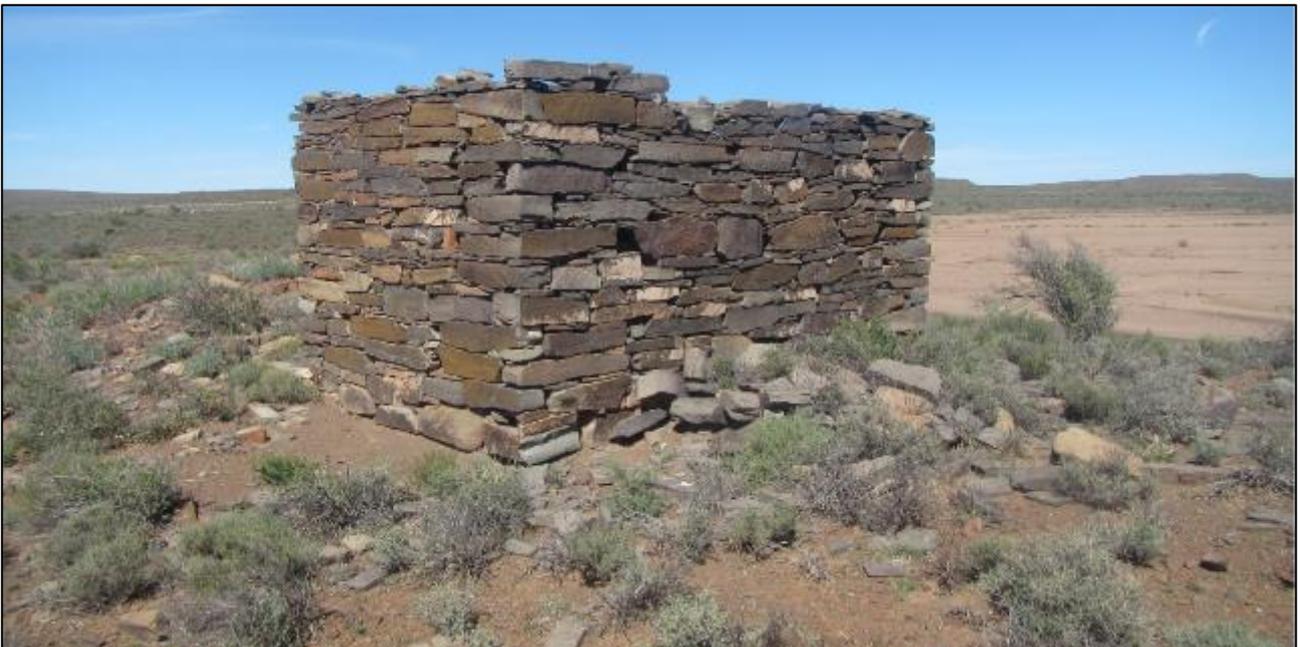
Figure 5-24: The stone-walled house on the dam wall at waypoint HL1595.

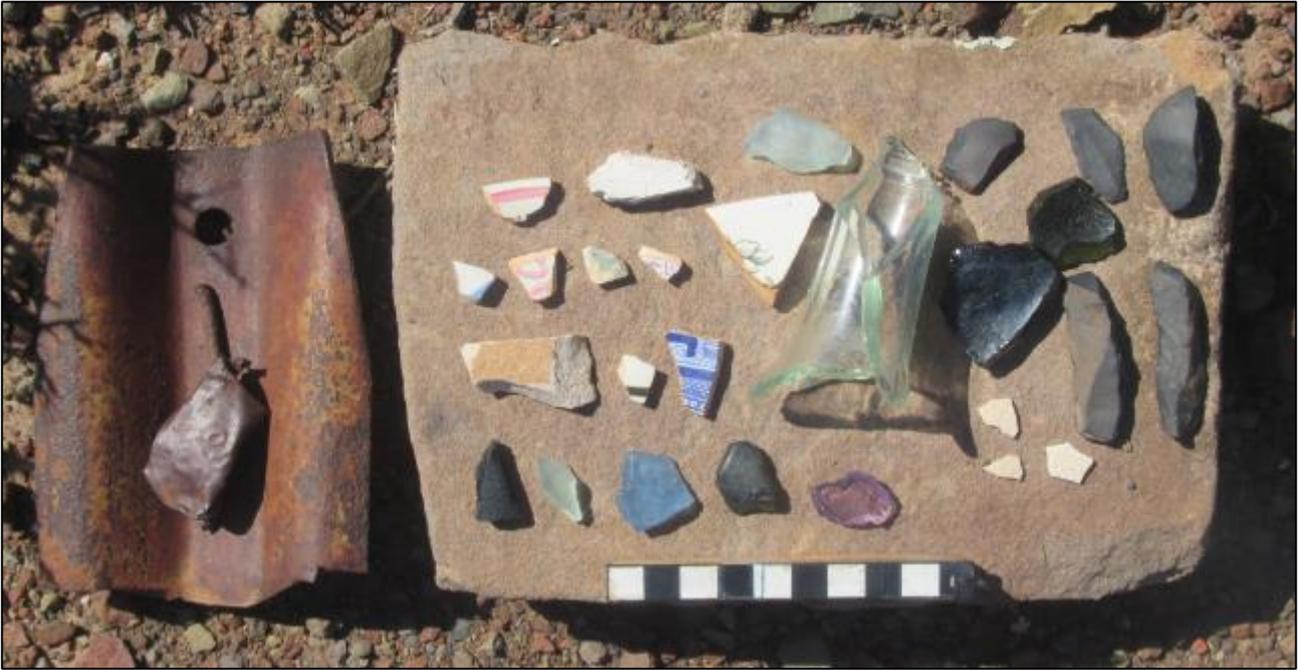
Figure 5-25: Artefacts found alongside the ruin at waypoint HL1595.

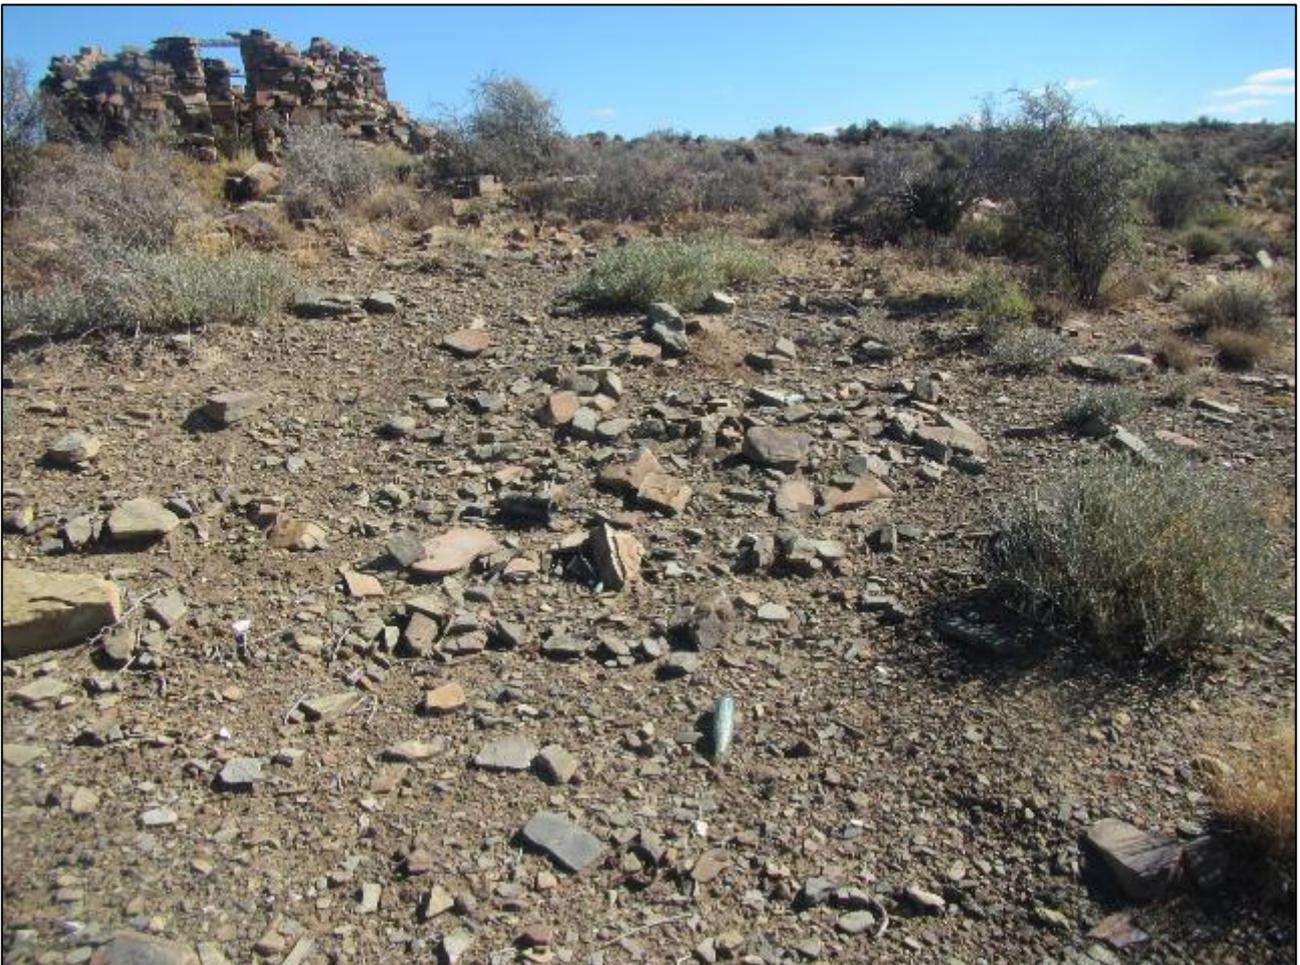
Figure 5-26: An ephemeral ash and rubbish dump at waypoint HL1843.

rubbish dumps were rare but one fairly ephemeral one was seen in the corridor at waypoint 1843, also associated with a stone house ruin (Figure 5-26). Interestingly, it had a dolerite lower grindstone on it (Figure 5-27). While this may have been an LSA artefact that happened to be there, it is very likely that the European residents of the house were in fact using this item of LSA technology. Two glass bottles – one complete and one almost complete – were also found there (Figure 5-28).

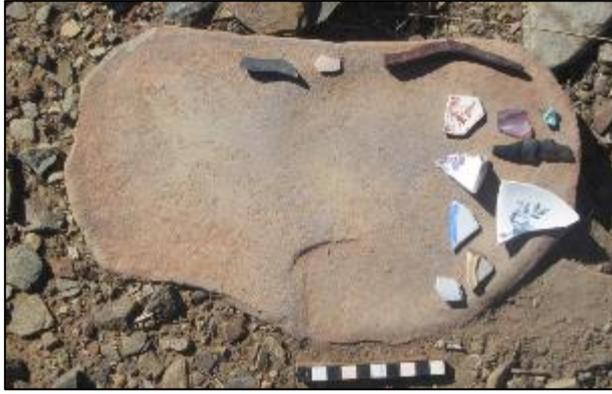
Figure 5-27: Lower grindstone and artefacts from the dump at waypoint HL1843. Scale in 1 cm intervals.

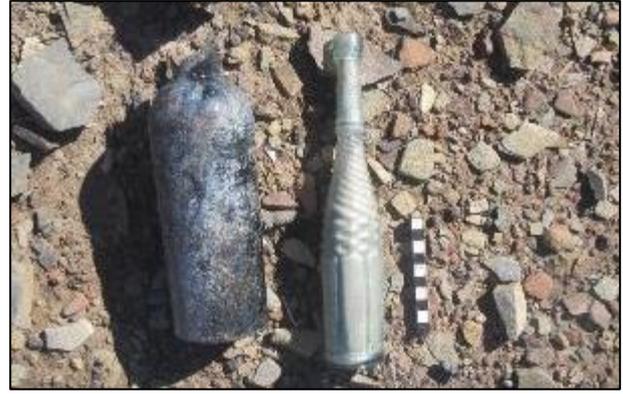
Figure 5-28: Two glass bottles from the dump at waypoint HL1843. Scale in 1 cm intervals.
