HERITAGE IMPACT ASSESSMENT: PROPOSED HOOGLAND SOUTHERN GRID CONNECTION, BEAUFORT WEST MAGISTERIAL DISTRICT, WESTERN CAPE

Required under Section 38(8) of the National Heritage Resources Act (No. 25 of 1999)
as part of a Heritage Impact Assessment.

Hoogland Southern Grid Connection

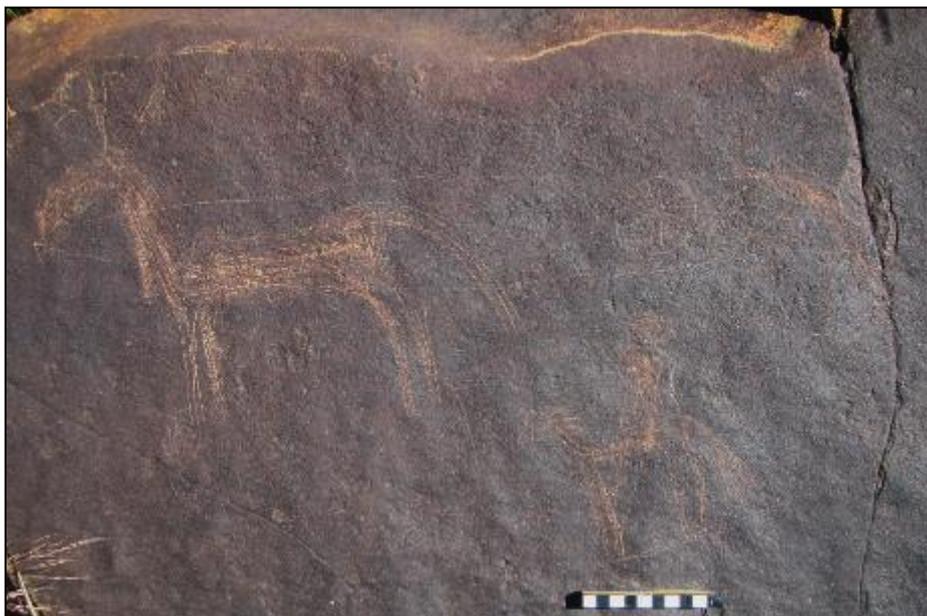
Figure 5-29: Historical scratched engraving of a horse and chariot and a horse and rider at waypoint HL1576. The chariot looks incomplete. Scale in cm.

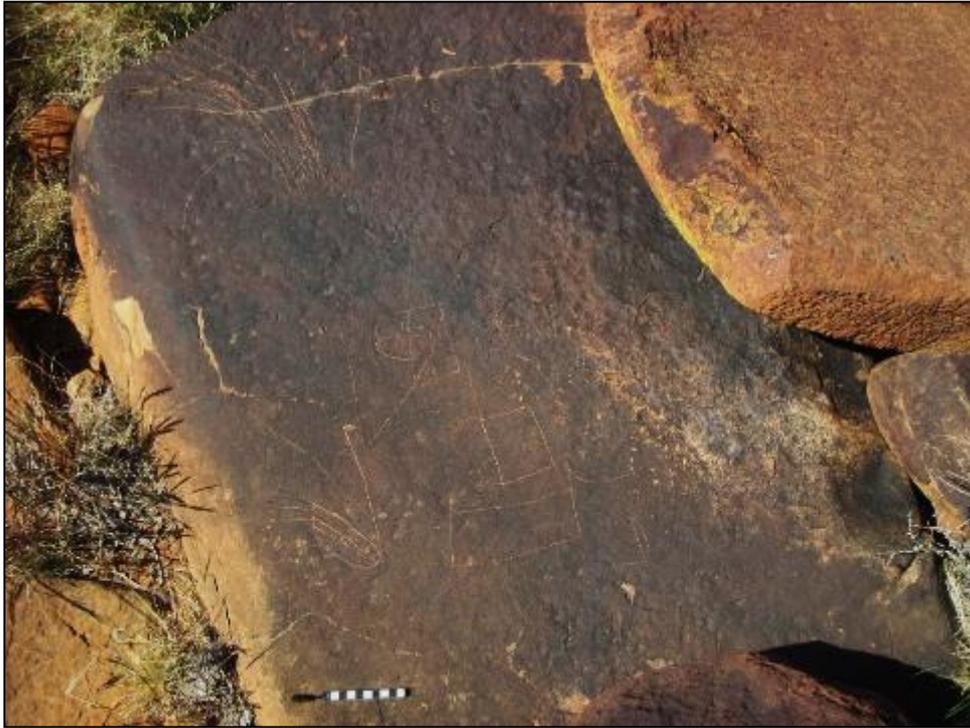
Figure 5-30: Historical scratched engraving of an ostrich and some crude carriages at waypoint HL1573. Scale in cm.

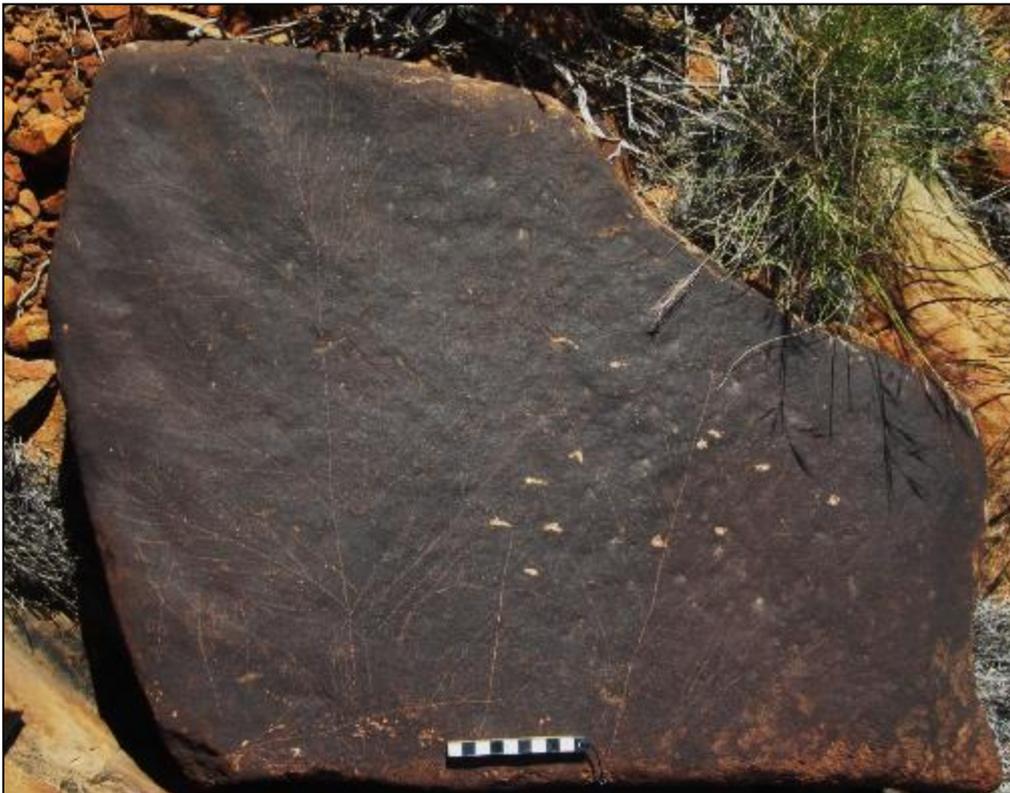
Figure 5-31: Historical scratched engraving of what appear to be plants at waypoint HL1573. Scale in cm.

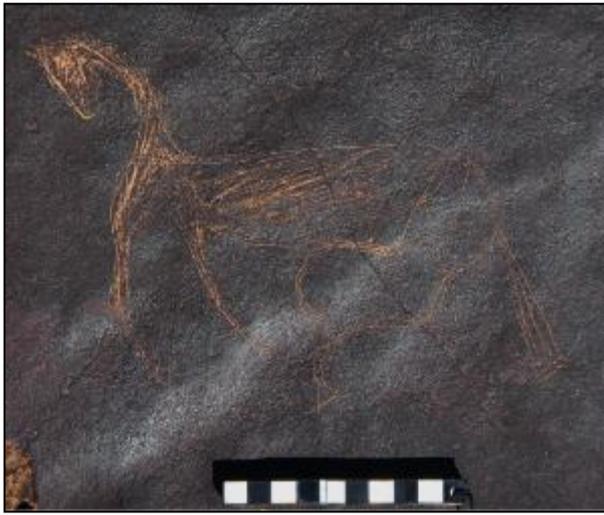
Figure 5-32: Historical scratched engraving of a horse at waypoint HL1577. Scale in cm.

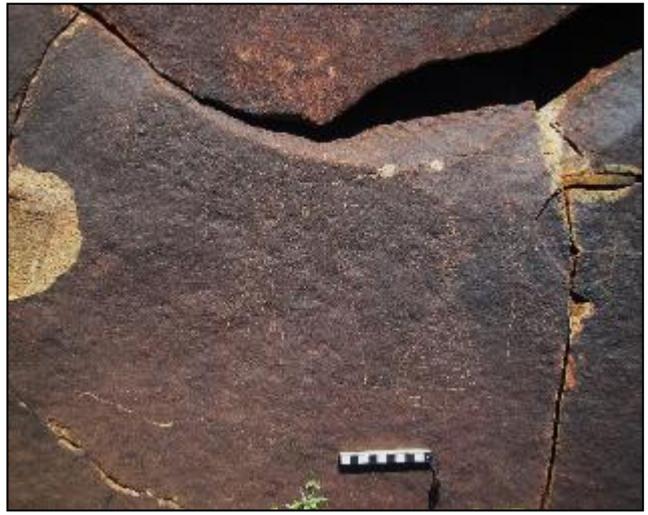
Figure 5-33: Historical scratched engraving of a line of ladies in dresses at waypoints HL1579. Scale in cm.

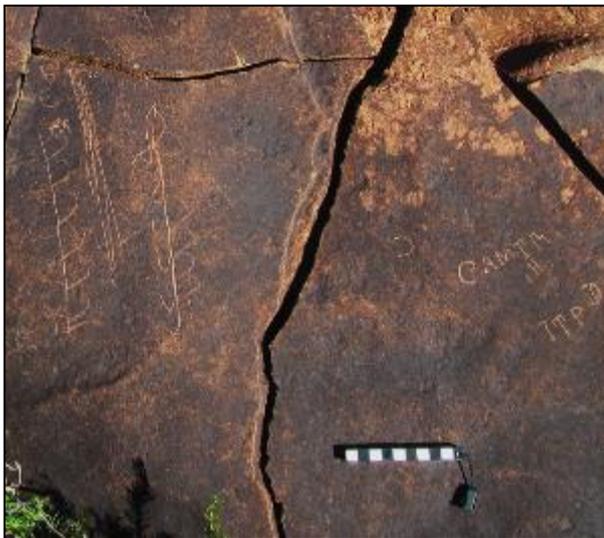
Figure 5-34: Historical scratched engraving of what may be plants and some lettering at waypoint HL1580. Scale in cm.

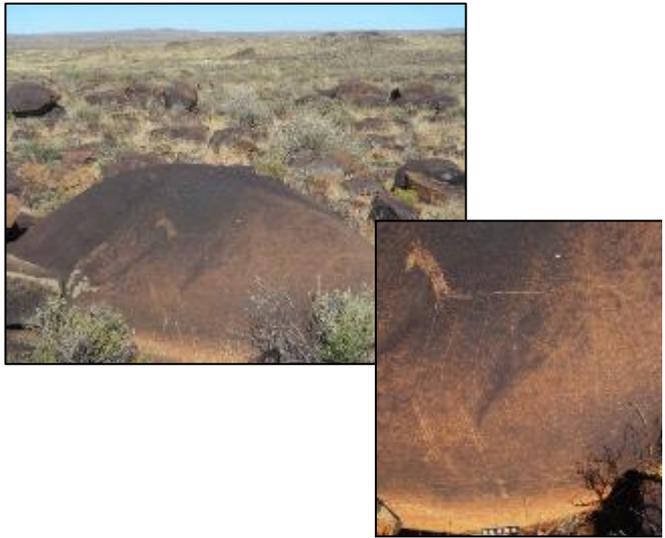
Figure 5-35: Historical scratched engraving of a horse at waypoint HL1832 in HL03. Scale in cm.

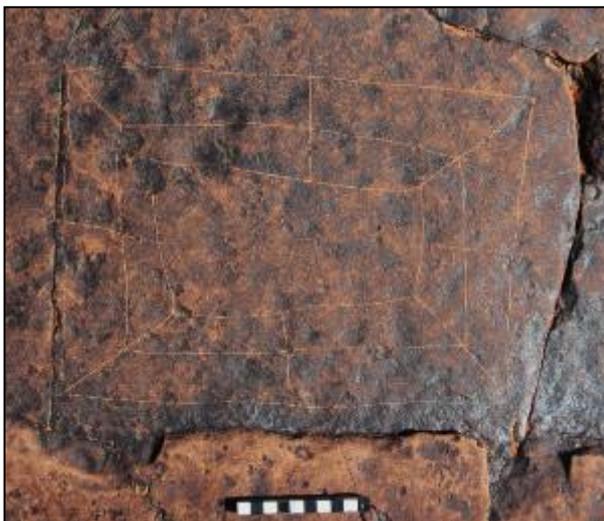
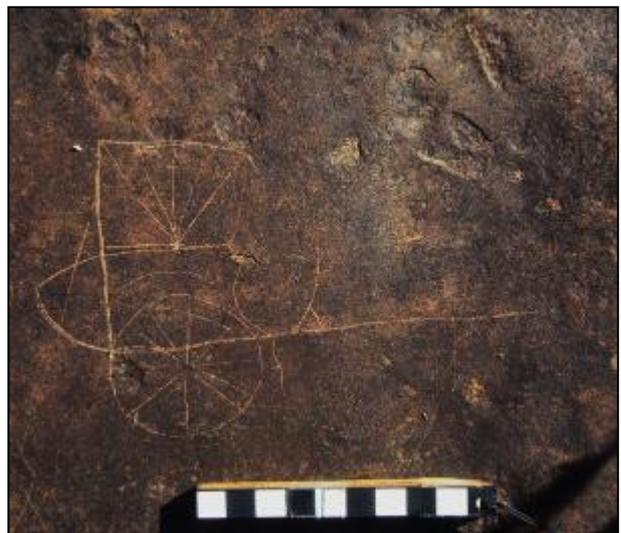
Figure 5-36: A historical scratched Nine men's morris gameboard at waypoint HL1838 in HL03. Scale in cm.

Figure 5-37: A historical scratched engraving of a Cape Cart at waypoint HL1857 in HL03. Scale in cm.

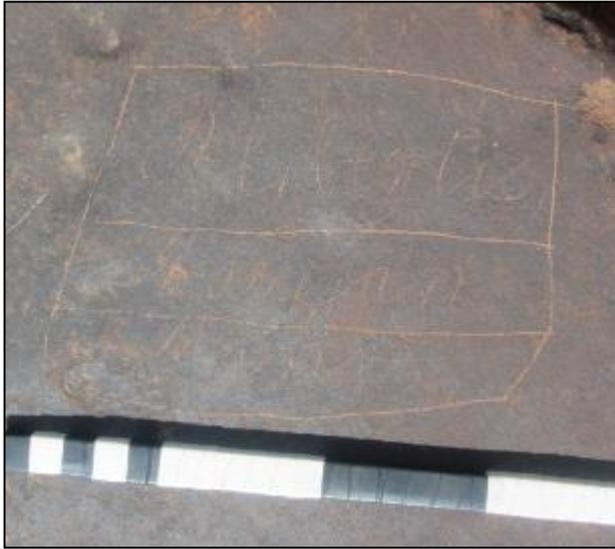
Figure 5-38: Writing at waypoint HL146 in HL03. Scale in 1 and 5 cm intervals.

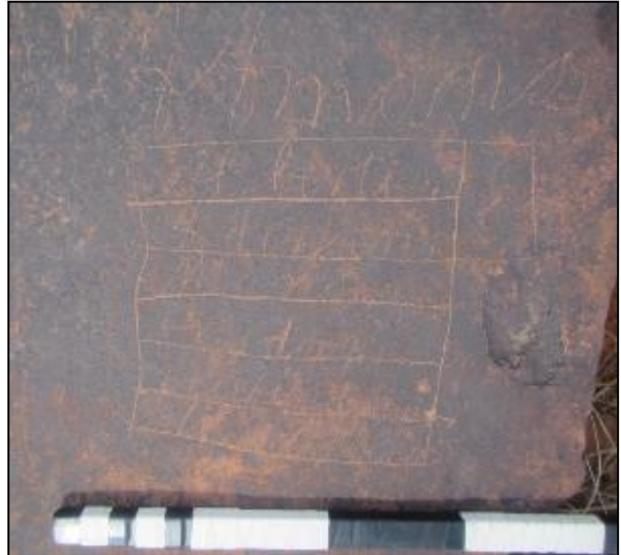
Figure 5-39: Writing at waypoint HL146 in HL03. Scale in 1 and 5 cm intervals.

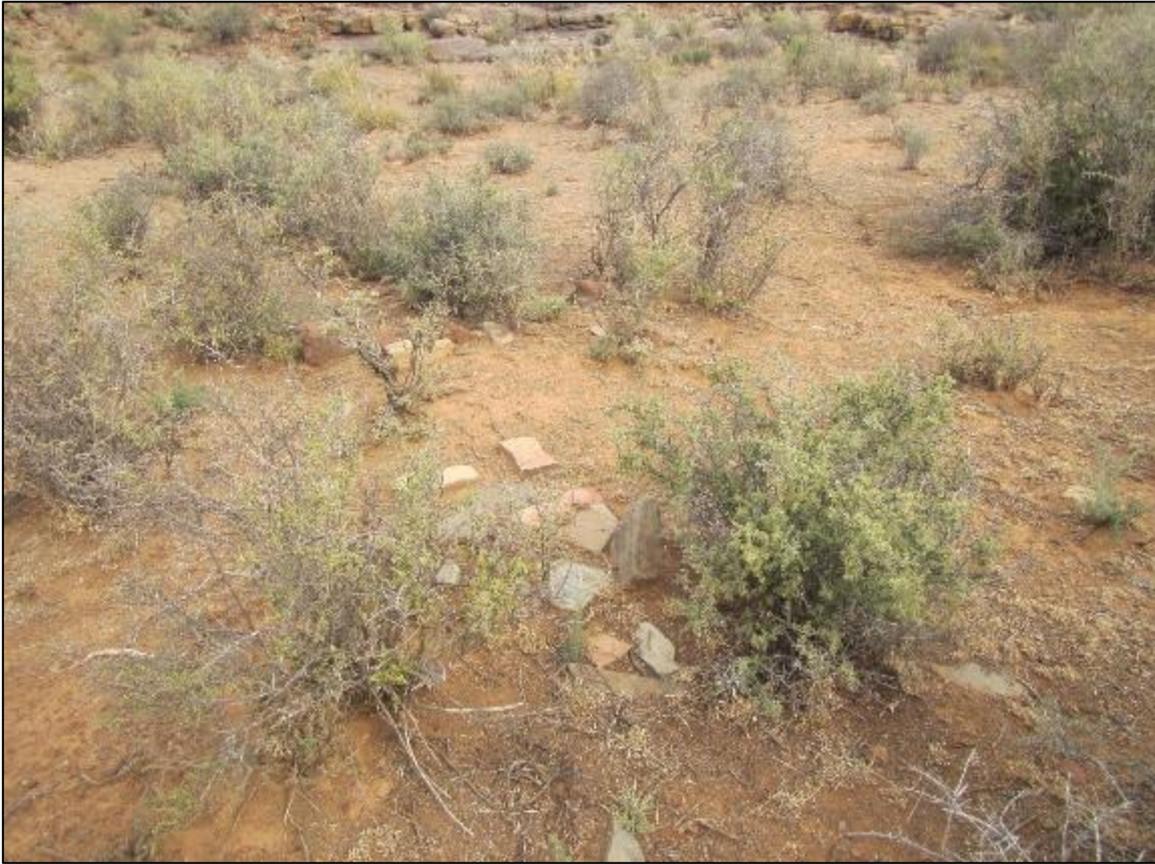
Figure 5-40: Graveyard at waypoint HL1821.

Graves were unusually rare with just two recorded within the study area. These were a pair of graves associated with a farm complex at waypoint HL1821 inside the corridor. Figure 5-40 shows one of these two graves.

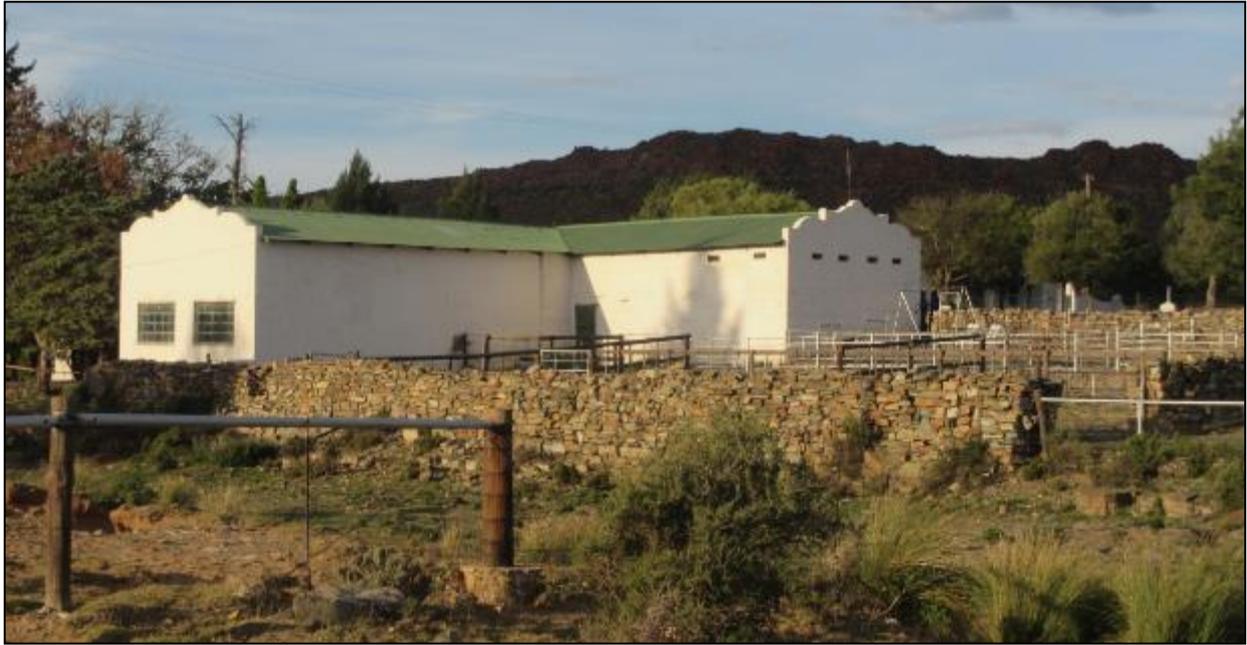
Figure 5-44: An early-mid-20th century shed within the Leeuwkloof farm complex (waypoint NV1850).

The corridor only includes two sets of historical buildings, but only one of these has been visited, and even then it was only viewed and recorded from the public road. This is Leeuwkloof at waypoint NV1850 within the corridor (Farm 43). Figure 5-44 to Figure 5-46 show some of the structures. The 1959 aerial photograph shows all structures to have been present at that time (Figure 5-47). The other is Eyerkuil (Farm 39). Interestingly, this complex is associated with many flood barriers built across the adjacent floodplain. These would likely have been cultivated in the past during periods of higher rainfall. These barriers are readily visible on aerial photography (Figure 5-48). The southern part of the area shown is in the corridor, but the farm complex itself is not.

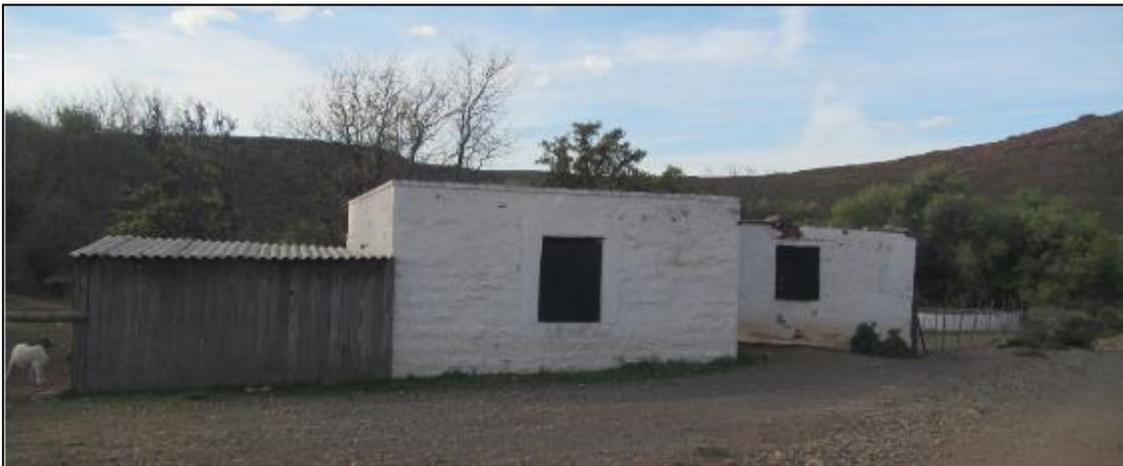
Figure 5-45: A stone-walled outbuilding within the Leeuwkloof farm complex (waypoint NV1850).

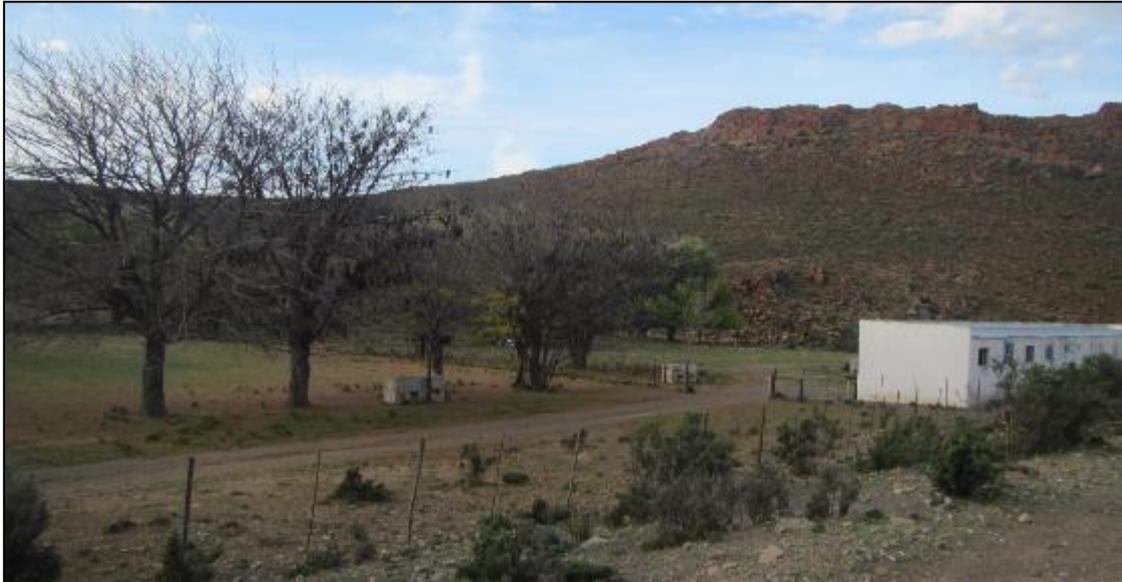
Figure 5-46: 20th century stables within the Leeuwkloof farm complex (waypoint NV1850).

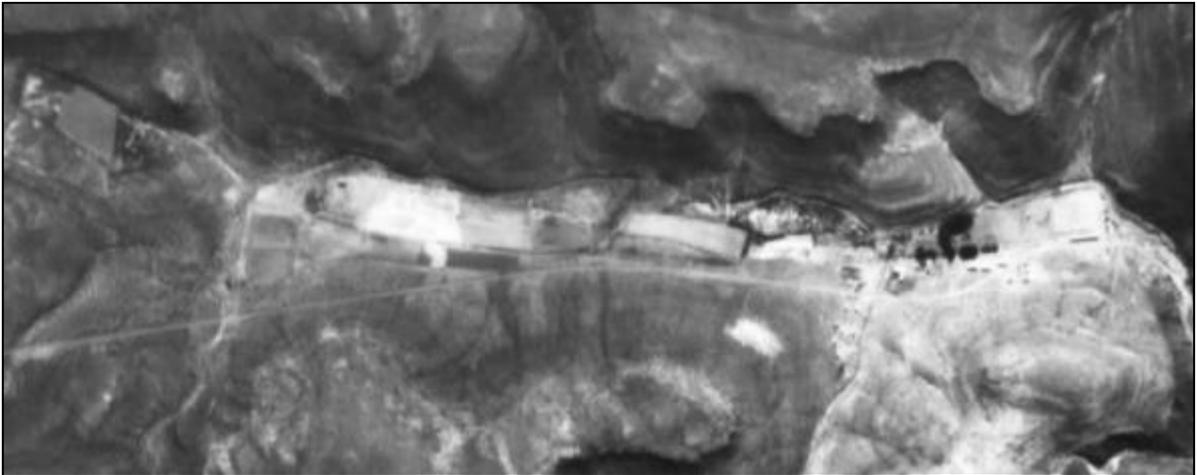
Figure 5-47: Aerial photograph (Job 434, strip 017, photograph 06391) of the Leeuwkloof farm complex from 1959 showing all structures to be present (waypoint NV1850).

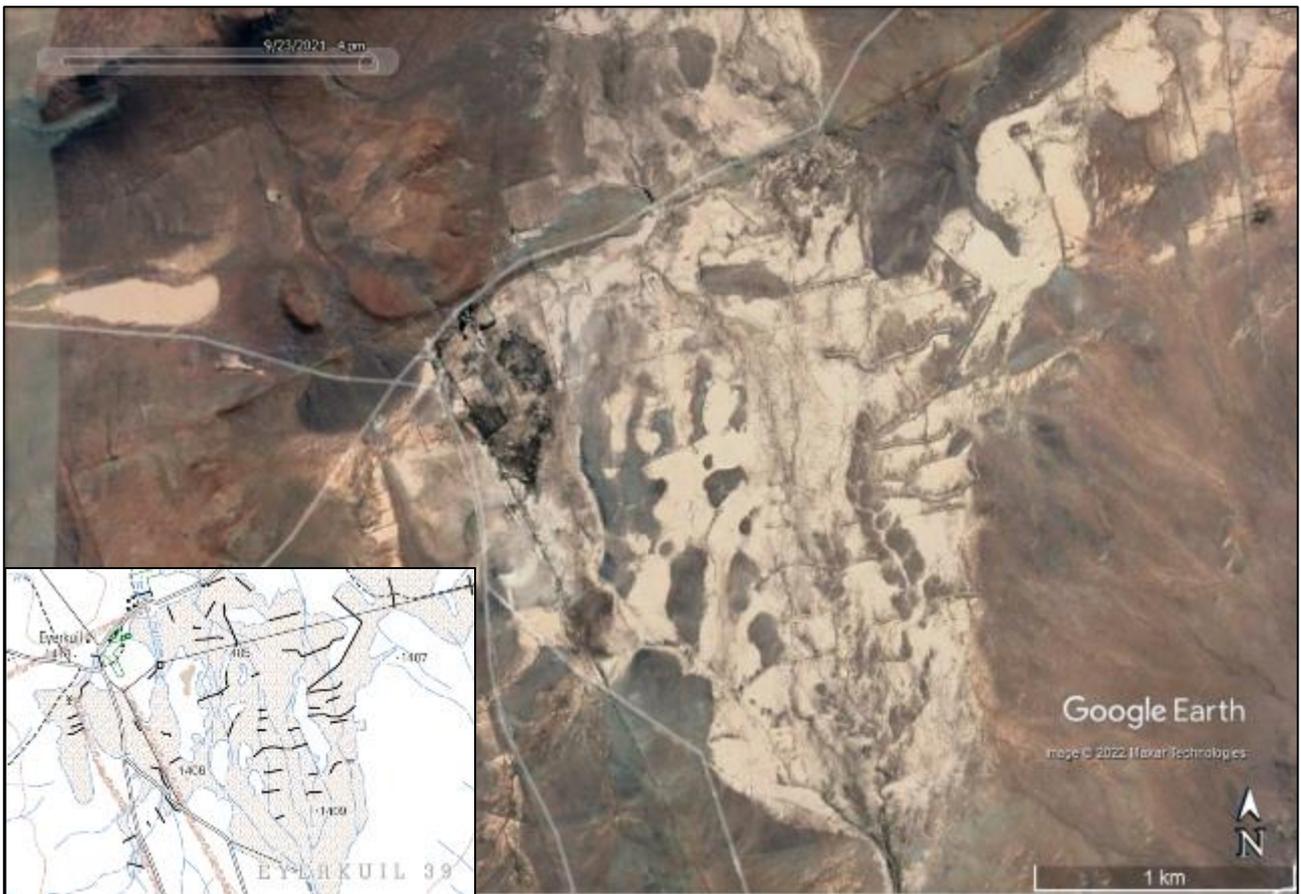
Figure 5-48: Aerial view of the Eyerkuil farm complex showing the many flood barriers constructed in the floodplain. The inset shows them mapped on a 1:50 000 map for greater clarity.

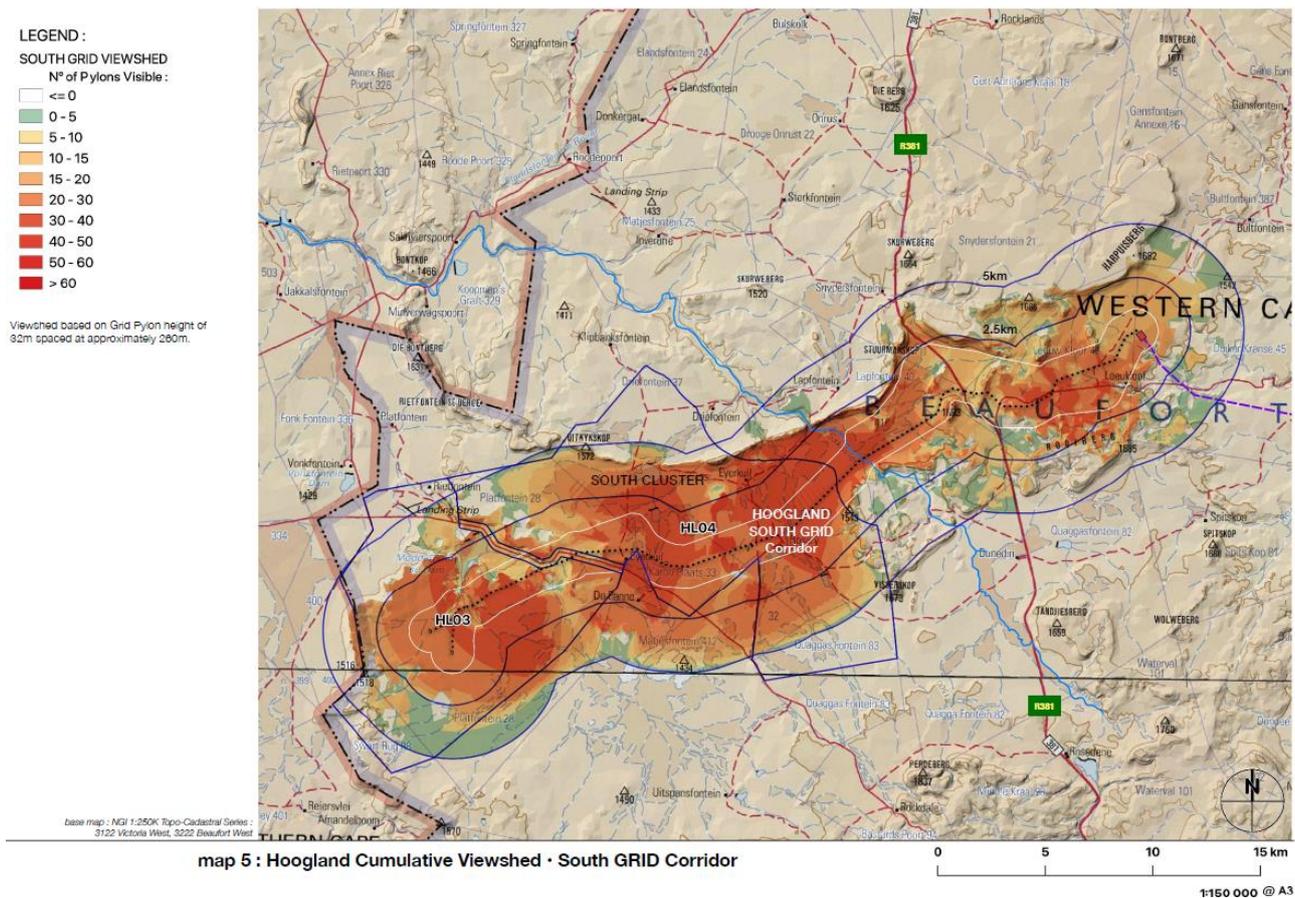
Figure 5-49: Viewshed map of the study area. Source: Lawson & Oberholzer (2022: Map 5).

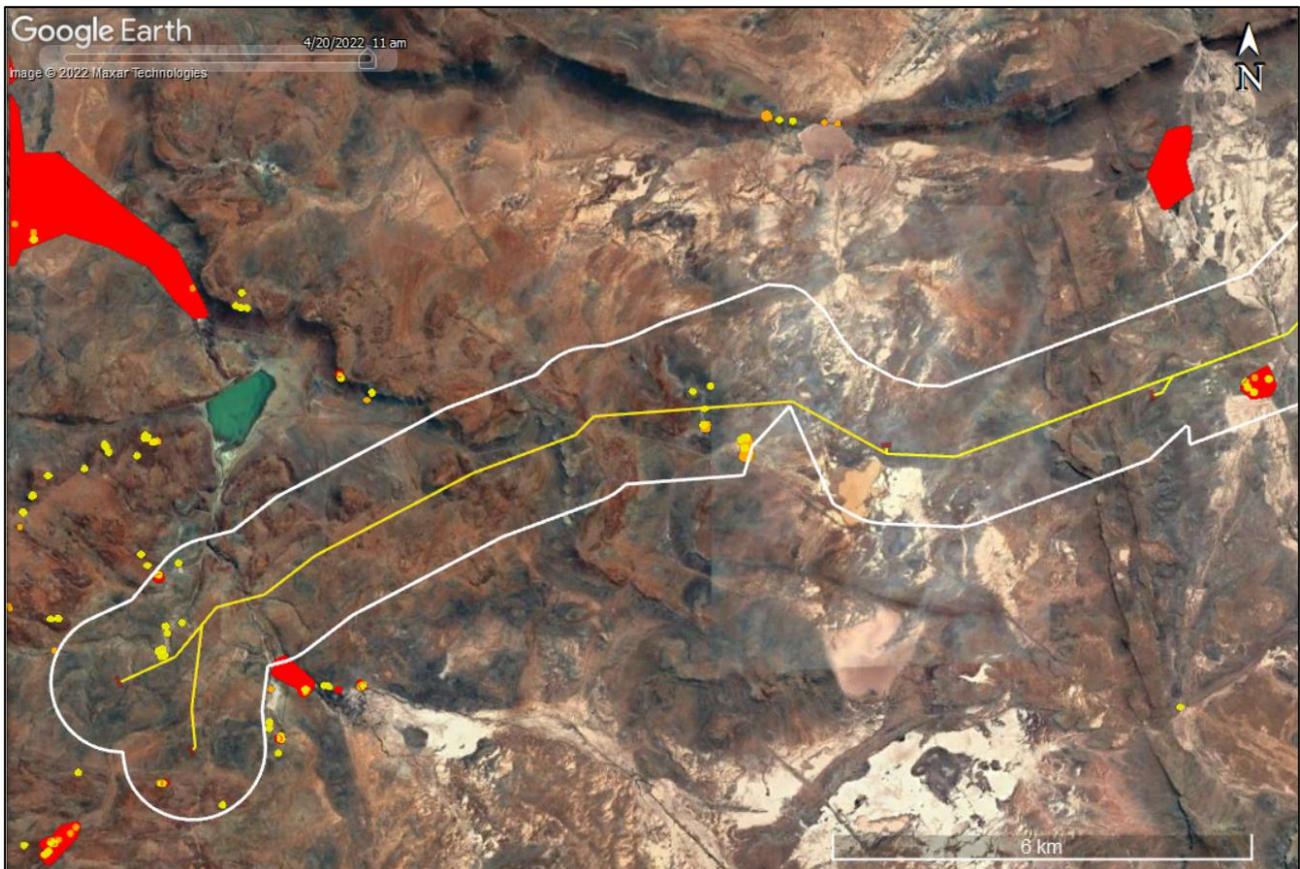
Figure 6-1: Sensitivity map of the western half of the grid corridor. Red, orange and yellow shaded areas are high, medium and low sensitivity respectively.

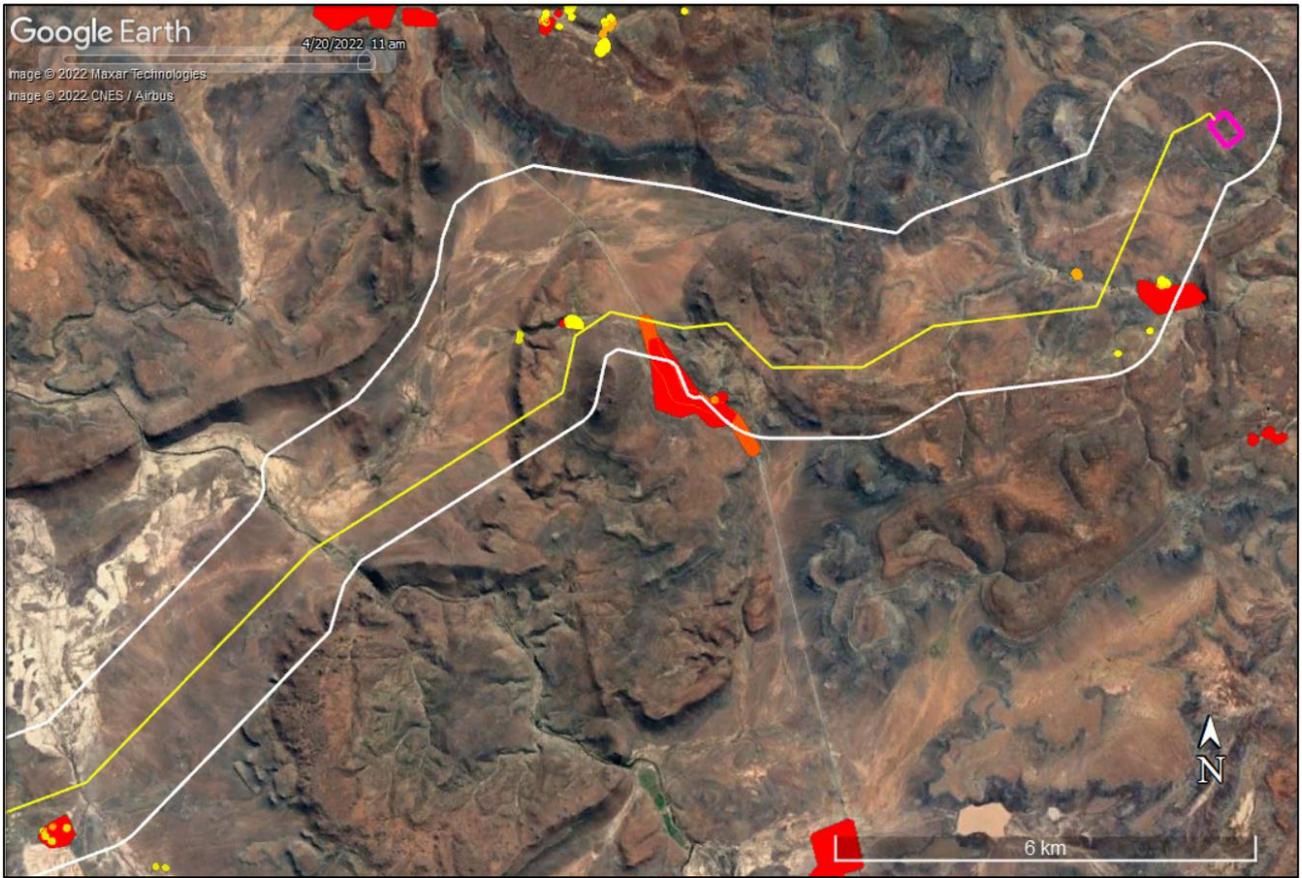
Figure 6-2: Sensitivity map of the eastern half of the grid corridor. Red, orange and yellow shaded areas are high, medium and low sensitivity respectively.

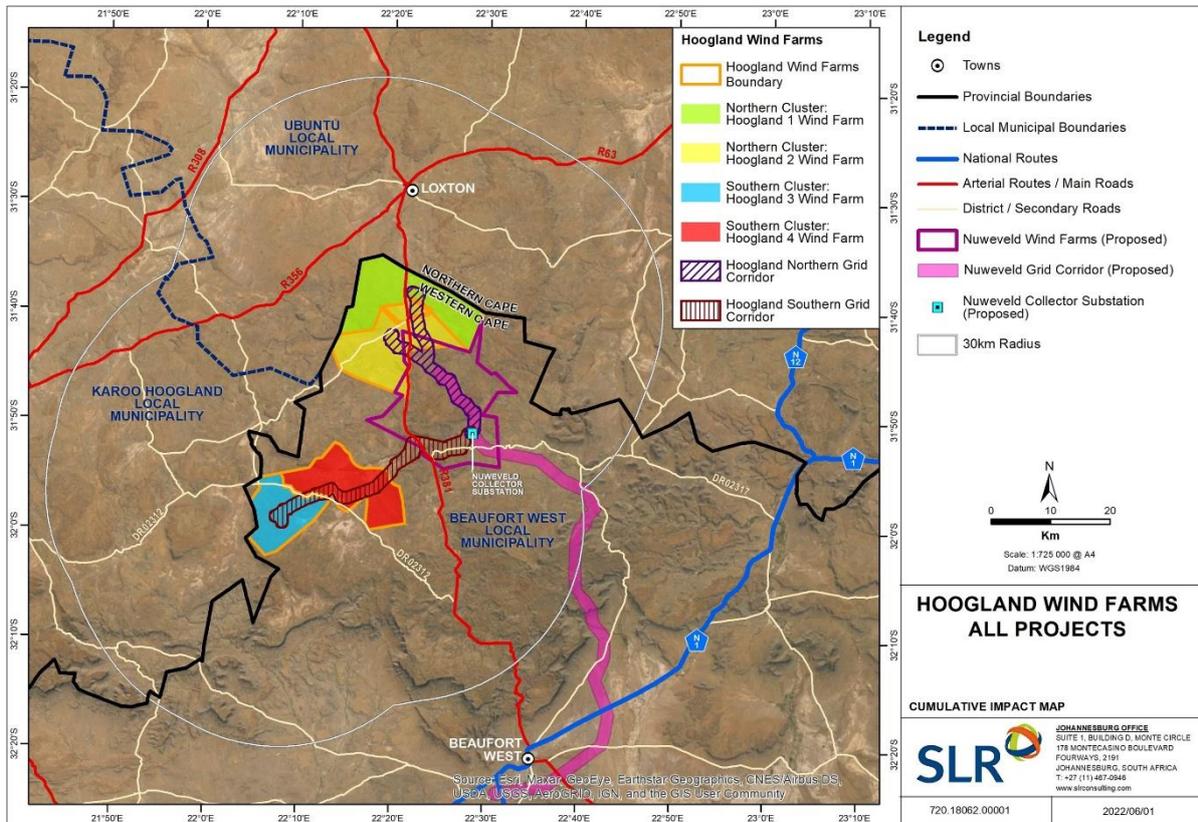
Figure 7-1: Cumulative Map indicating renewable energy facilities within the 30km buffer of the Hoogland Wind Farms and Grid Connection.

Other than the proposed Nuweveld Grid Connection, there are currently no approved or existing high voltage powerlines in the area within a 30 km radius of the project site (Figure 7-1). The nearest operational wind farm from the site is the Noblesfontein Wind Farm located approximately 65 km to the east. In addition, the South African Renewable Energy EIA Application Database (REEA) (“REEA_OR_2021_Q3”) shows several renewable energy projects (solar) authorised close to Beaufort West. Further research confirmed that none of these projects are going ahead/have a valid EA. The cumulative impact assessed will therefore be the collective impact of the four Hoogland Wind Farms and Grid Connection applications with the three Nuweveld Wind Farm and Gridline applications (Figure 7-1). The low voltage lines supplying the local farms result in negligible impacts to the landscape and are not taken into consideration in the assessment of cumulative impacts.
